# Advantage Home Inspections

## PROPERTY INSPECTION REPORT

Concerning: \_\_\_\_\_ **01-21-12**  
(Address or Other Identification of Inspected Property) (Date)

By: **Don Powell 8534** \_\_\_\_\_  
(Name and License Number of Inspector) (Name of Realtor)

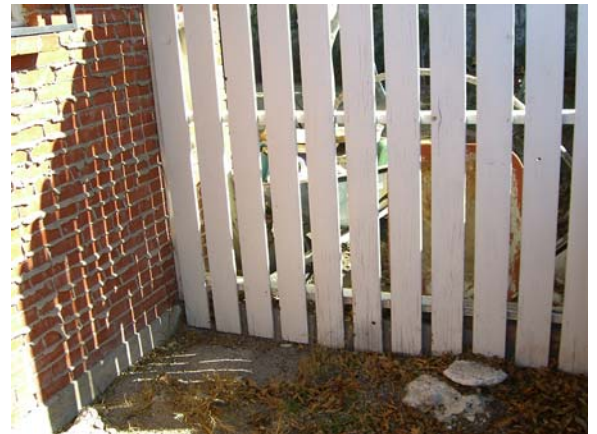
1) I feel uncomfortable with the ability of rain water to easily drain from the back yard to the front. Currently, all drainage must go around the North end of the house because the South side of the house is blocked to prevent drainage. I recommend that the area on the South side be repaired to allow water to drain to the front in that area also.

This gate on the South side has bricks on the bottom that prevents proper drainage. I recommend that this be repaired.

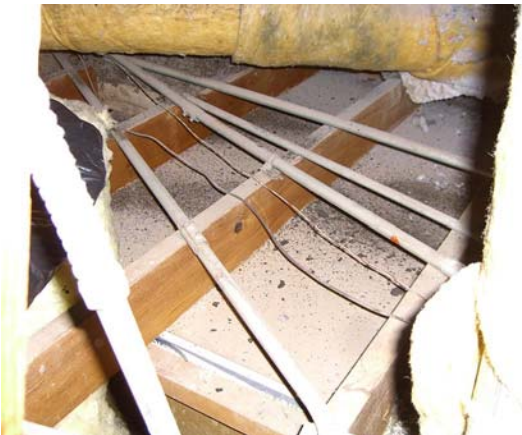
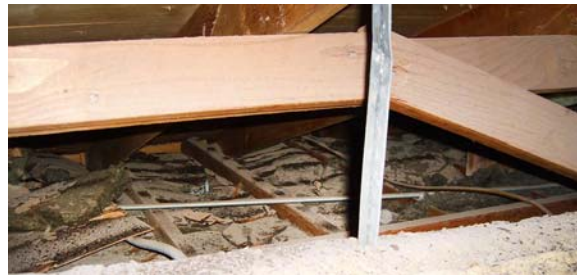
- 1) By today's standards the insulation in the attic is considered poor. R30 is required in this energy conscience times. You probably have about 12 R-value now so you would need to add about 6-8 inches of blown insulation to get it up to the new requirements. This, of course, would greatly improve the energy efficiency of the house.
- 2) Not only is the insulation lacking, it is also missing in many locations. This is not energy efficient and should be repaired with the addition of insulation in these areas. See two photos below.
- 3) I observed some water penetration evidence on the rafters in the attic. This is not unusual in a home this old. The last roof probably took care of any leaks. I did not see any current leakage.

Even if you do not add blown insulation, you should repair these areas that do not have any insulation.

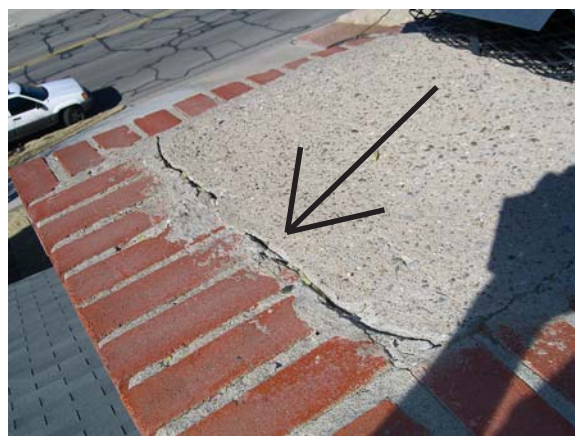
1) The capping of the chimney needs repair work to repair the cracks that have developed. Water can penetrate these cracks and get into the house.

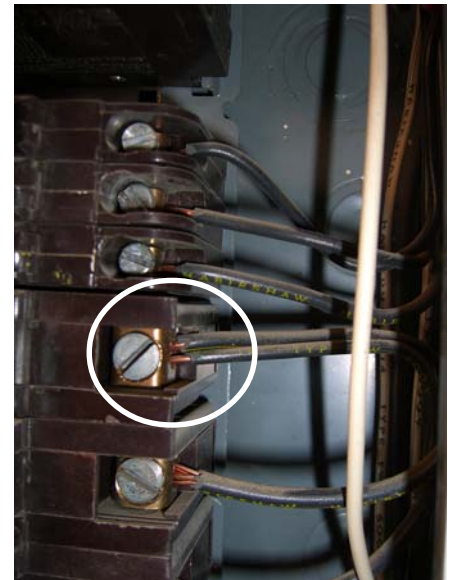
2) A double tap was observed in the panel. A double tap is when two wires are connected to one breaker. The breakers are only designed for one wire, not two. See photo.

**Double tap right here**

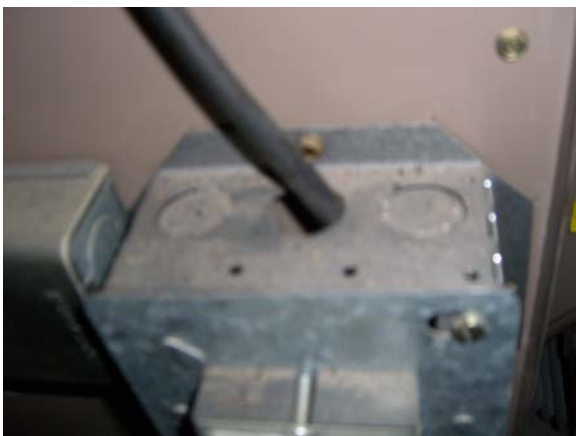
10) The wire to the furnace goes through the sharp metal junction box. This box should have a grommet to protect the wire from damage.

This wire to the junction box for the furnace is going through that should be grommet protected

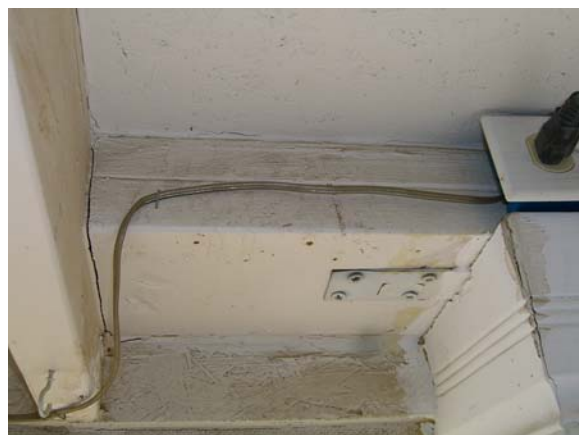
11) There is a wire going to as outlet outside for the patio. This wire is not appoved wire for this application and it is not protected by conduit. The outer plastic sheathing of this wire does not provide any kind of protection against punctures, perforations, lacerations or any other harm that may very well come to electrical wiring in residences. Because of this, unprotected Romex must be protected. The protection usually comes in the form of metal conduit.

This wire to the outside outlet is unprotected and is the incorrect wire that you can use for this application.

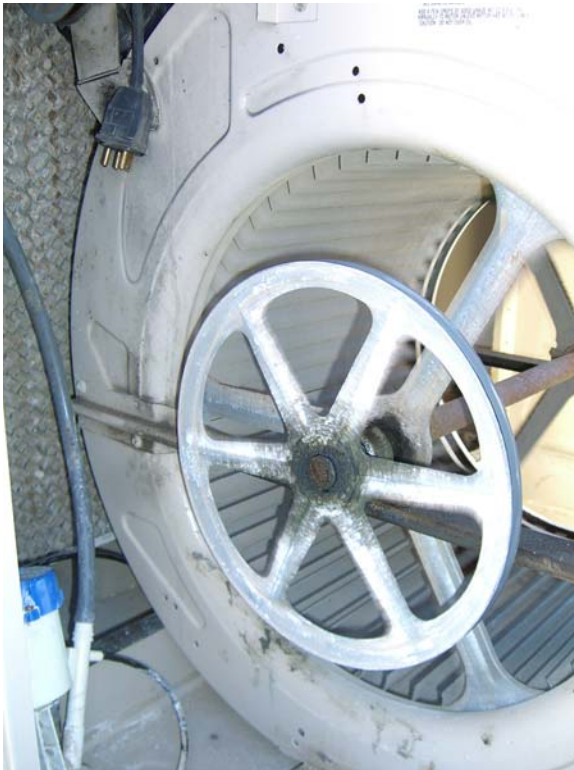
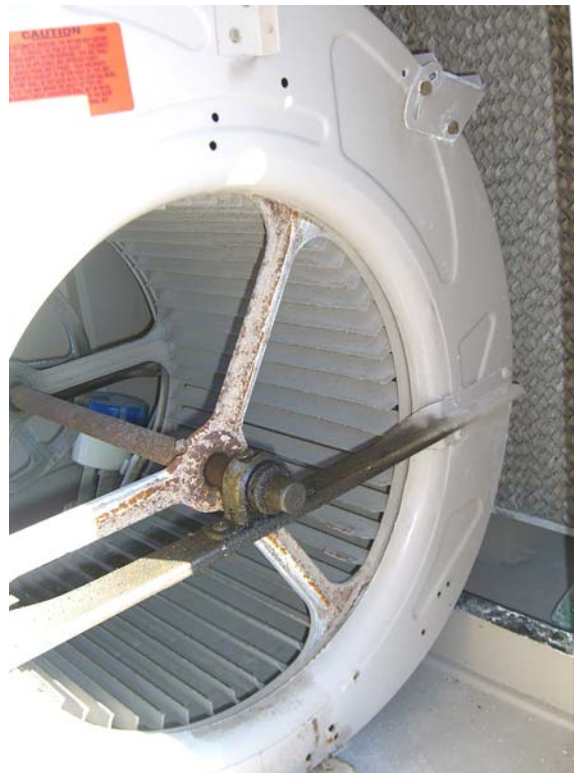
**COMMENTS:** Other than a couple rust spots that should be taken care of with minor maintenance, your unit appeared satisfactory. I do suggest that you replace the plastic lines with copper. Plastic lines do not stand up to the summer sun in this area.

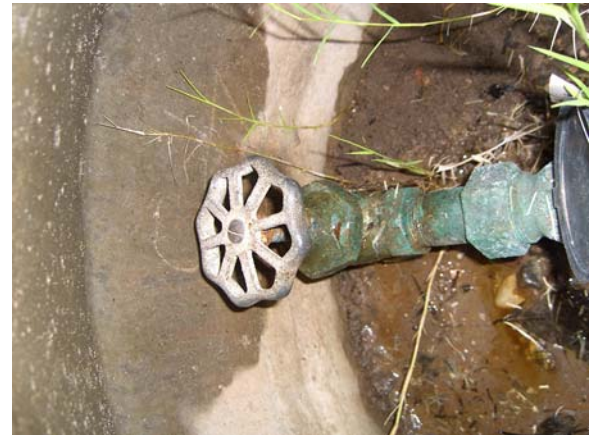
- 1) There is a small leak in the city meter on the city side of the meter. See photo.
- 2) The front and rear faucets do not have anti-siphon devices attached. See diagram below.
- 3) The commode in the hall bath is leaking in the area of where the tank attaches to the bowl.

Small leak on city side of meter.

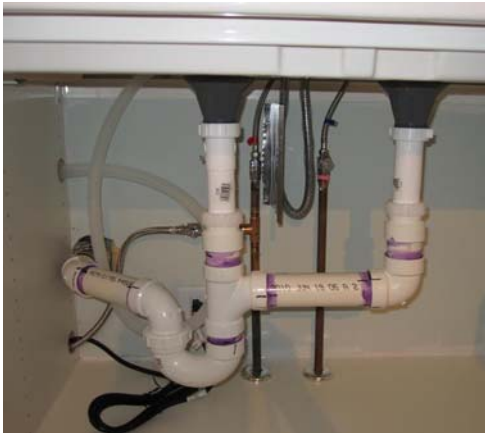
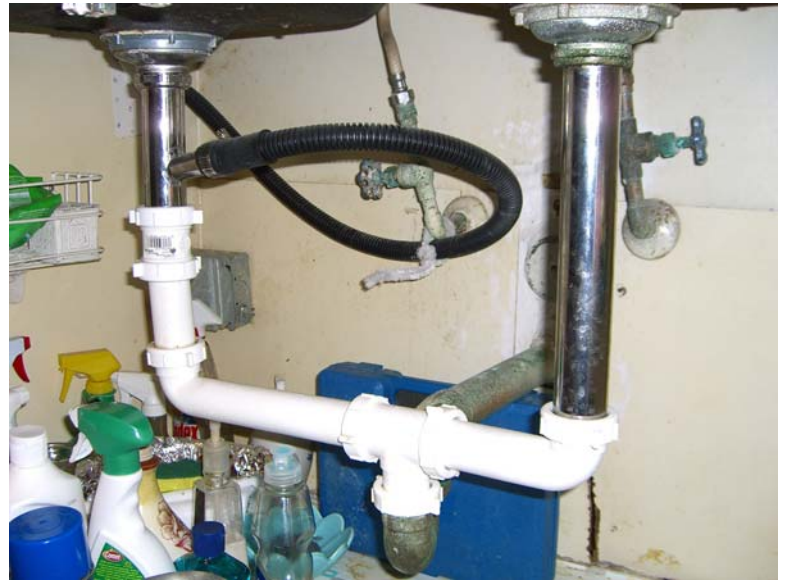
On the right is your setup and on the left is how it is supposed to look.

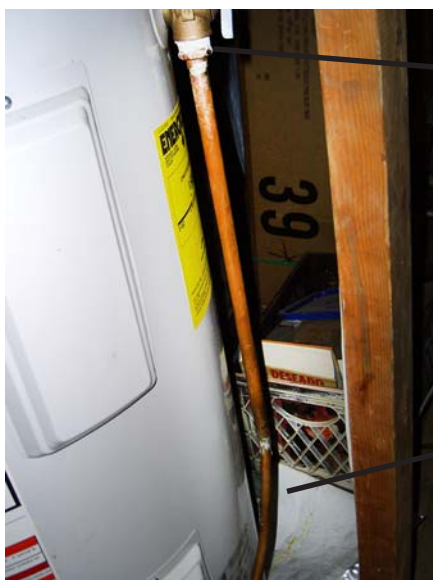
1) The pipe for the pressure control valve is incorrect. This pipe shall not be smaller than the diameter of the outlet of the valve served and shall discharge full size to the air gap. It appears that the valve for the water heater is about 3/4" but the pipe narrows down to 1/2".

Outlet 3/4"

3/4" outlet but the pipe narrows down to 1/2"

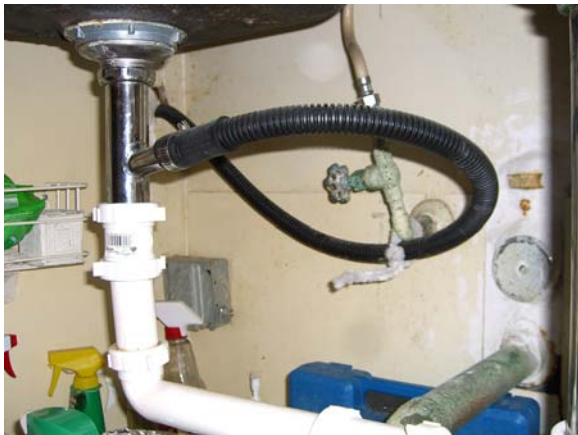
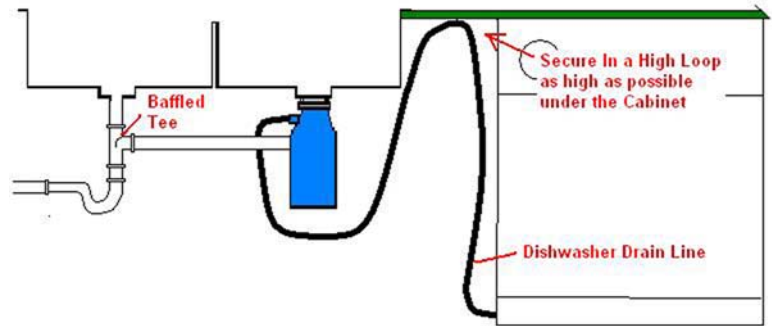
1) The anti-backflow device was not installed for the drainage of the dishwasher. Usually it is an air gap installed on top of the sink but this can be also achieved by making a loop as per the diagram.

The black dishwasher hose needs to have an air gap in it. This can be achieved by attaching it to the bottom of the counter as per diagram.

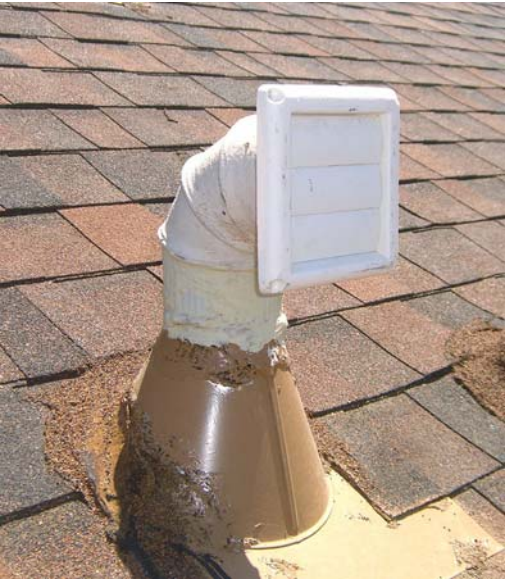
1) The back draft damper for the dryer on the roof is not correct. Backdraft dampers must be installed in dryer exhaust ducts to avoid outdoor air infiltration during periods when the dryer is not operating and to prevent the entry of animals. These dampers should be designed and installed to provide an adequate seal when in a closed position to minimize air leakage. Screens and/or sheet metal screws are prohibited on the duct termination because lint from the dryer will eventually clog the screen or catch on the screws to the point that no exhaust air will be able to reach the outdoors. This will build up to the point that a fire hazard is created.

This is yours. It is incorrect.

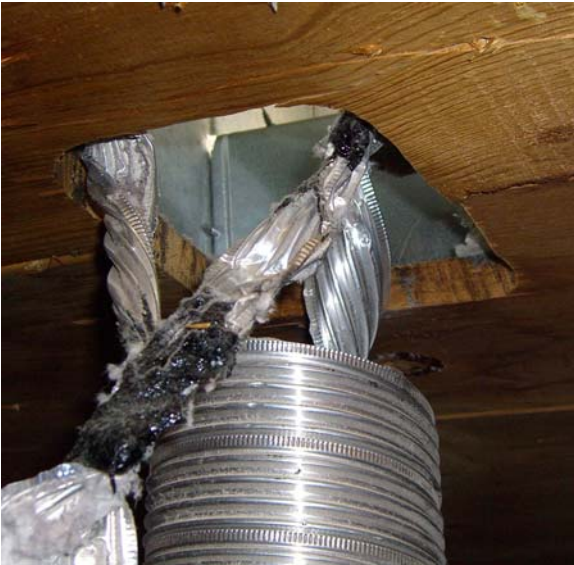
Also, the dryer vent isn't even attached to the vent going outside. This photo was taken inside the attic. This vent needs to be attached to the correct vent when you install it. This set up allows lint to be blown into the attic.
