Advantage Home Inspections

PROPERTY INSPECTION REPORT

Concerning: _____ **11-25-11**
(Address or Other Identification of Inspected Property) (Date)

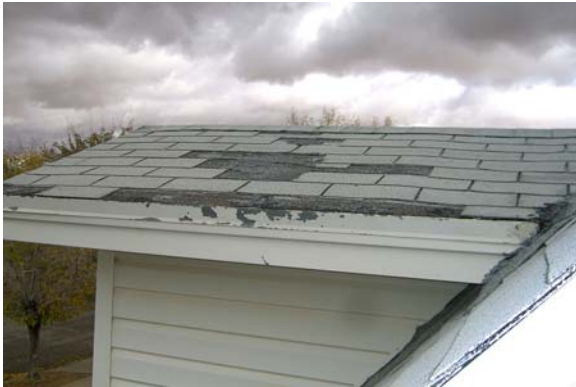
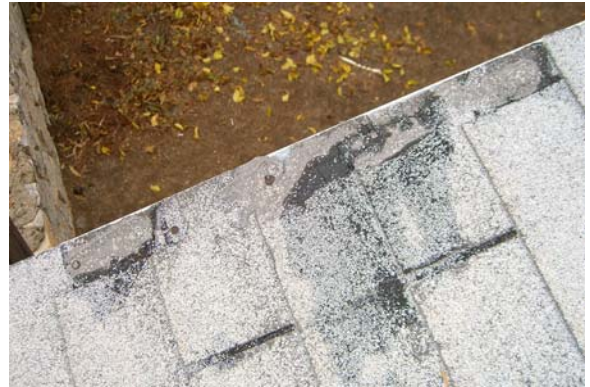
- 5) Many shingles are cupping and curling. This is also an indication of aging.
- 6) Attempted repairs have been made in several locations. See photos. These repairs appeared to be trying to fix a problem and not just maintenance.

Examples of repairs made: Left photo shows tar spread around on top of the dormer. The right photo shows a patch job not done correctly. This photo shows a lot of tar spread near the vertical wall. This glob of tar usually indicates that they had a leaking problem

*** We need to have a professional, third-party, qualified roofer look at this roof. **The issues pointed out with the roofing system needs to be repaired by a third party, certified, professional independent roofer. The roofer can evaluate the roof and make recommendations as how to proceed and how expensive it will be. This in-depth evaluation may also identify additional concerns not found during this limited, visual home inspection.**

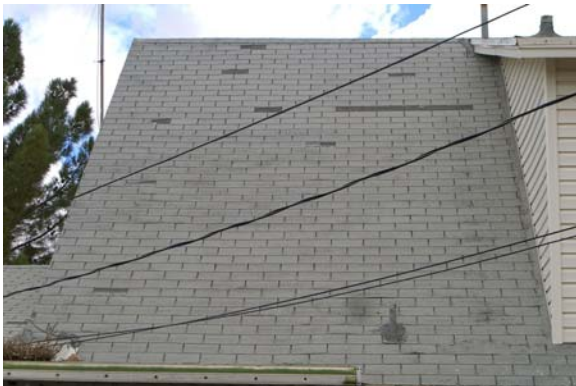
- 3) There are shingles missing in multiple locations. See photos.
- 4) Many shingles are lossing their aggregate (the gravel that covers them). This is an indication of age. See photo.

Multiple shingles missing from this area.

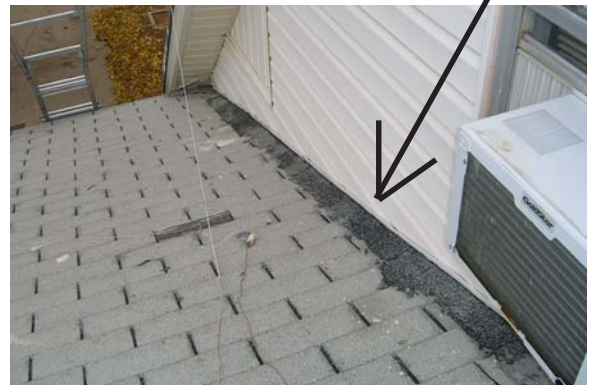
Some shingles missing from this area also.

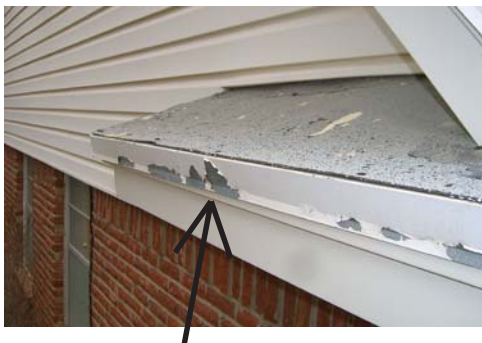
- 1) Paint was peeling off of the drip flashing all the way around the house. The flashing metal was not prepared correctly before painting. See photo.

Paint peeling from the flashing all around the house.

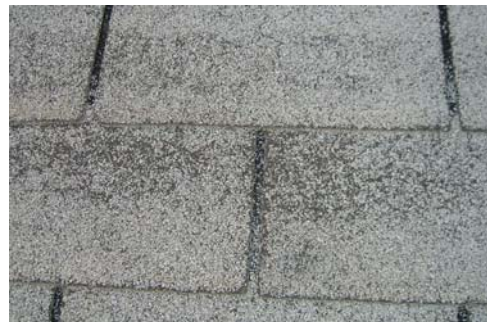
Shingles are showing their age when the aggregate is missing.

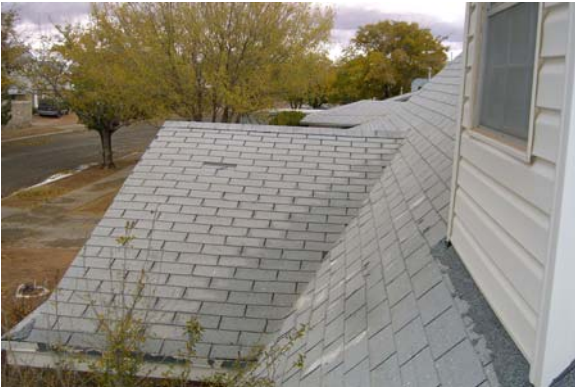
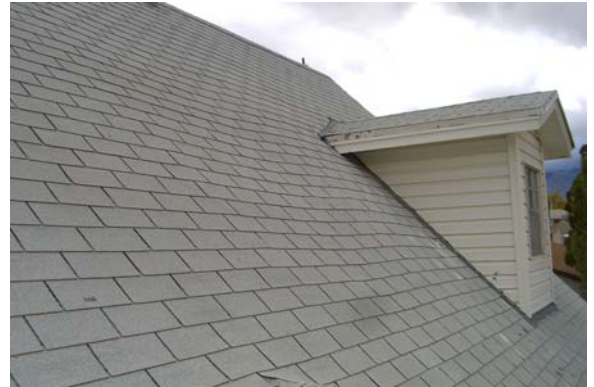
Photos showing other areas of the roof with missing shingles.

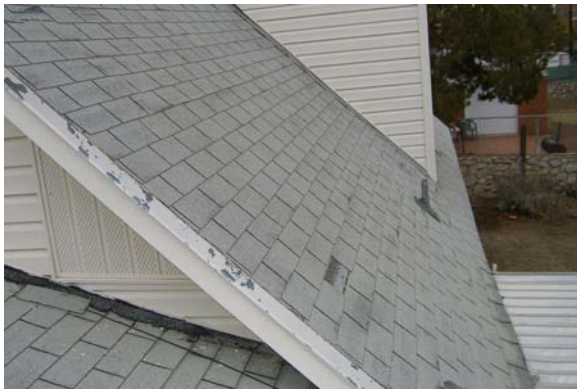
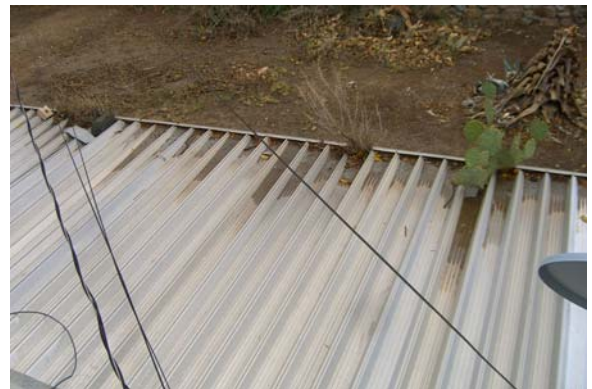
- 7) The patio roof was not professionally installed and consequently it leaks. It has also got so much dirt on it that it is growing vegetation. See photo.

Those are plants growing on top of the patio roof

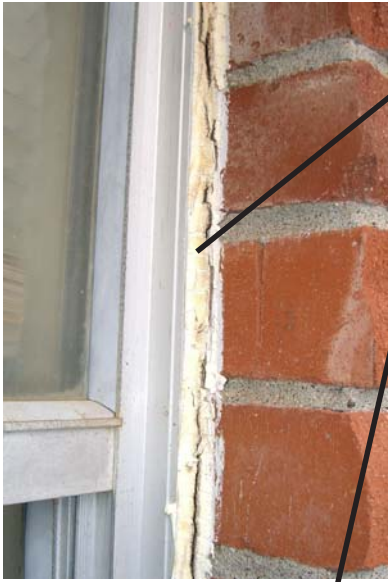
1) All windows need to have the caulking removed and new caulking installed. See photo. All exterior joints should be caulked (sealed) so that they are watertight and airtight. If they are not adequately caulked, wind-driven rain can enter and cause wood members to rot, metal ties to rust and masonry sections to crack and chip. In addition, cold air can infiltrate into the house causing higher heating costs. Caulking is a normal, relatively simple, maintenance item that needs to be done periodically.

All old caulk should be removed and new caulk added

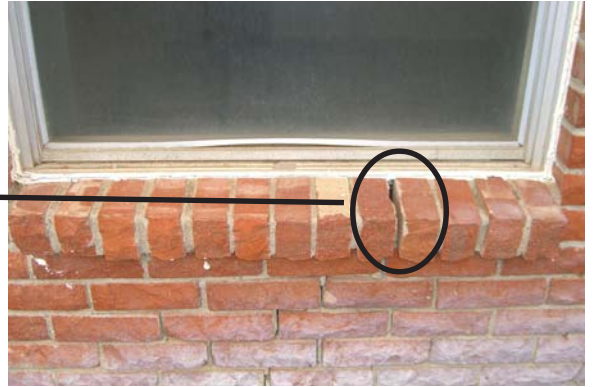
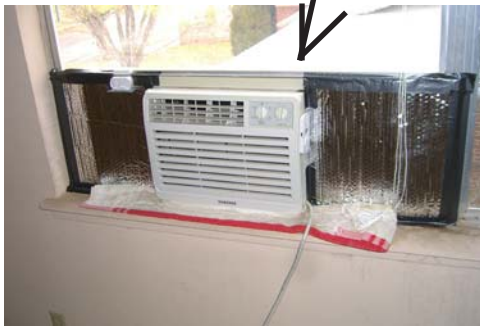
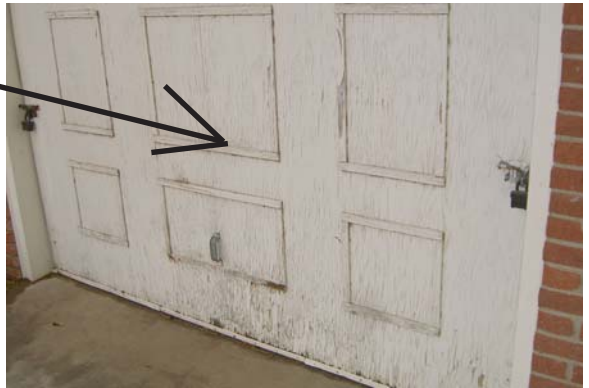
2) Many wooden areas around the house need painting to prevent any further deterioration. For example the garage door. See photo.

3) There are some cracks from the mortar falling from the bricks that need to be sealed. For example under the window in the back and under the window on the east side and in the front. See photo. Sealing all openings on the exterior will prevent water from getting into the house.

Bad opening where the mortar has fallen out.

Area around both window A/C's are not sealed very well.

Garage door needs painting

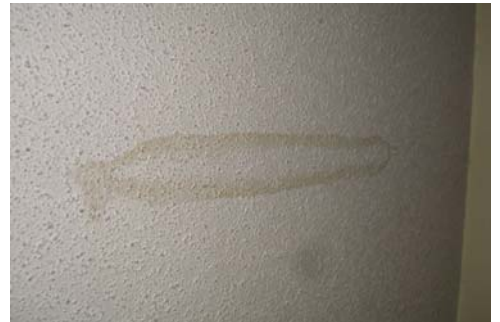
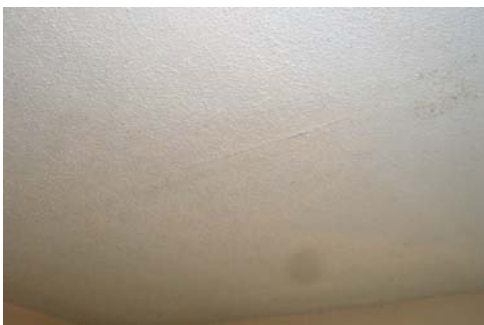
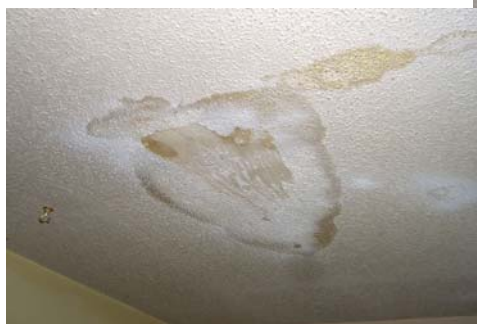
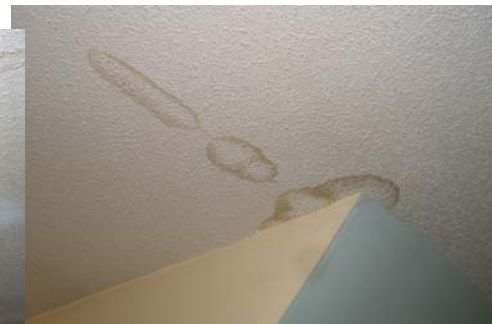
1) Multiply locations on the ceiling showed water damage. For example, two areas in the living room and one area in each bedroom and in the kitchen. See photos. It was raining when I did this inspection. The damaged spots did not show any new moisture. However, we still don't know if these leaks have been repaired.

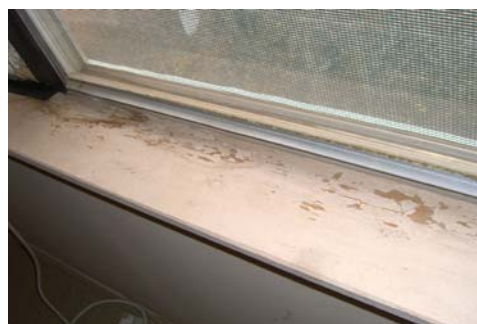
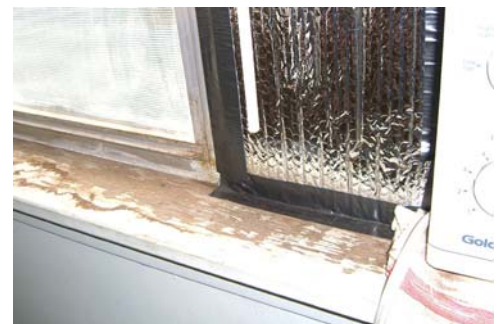
- 3) As I said, the windows are old style and are not sealing very well against rain. Many of the window sills around the house show water damage. See photo.

Window sills show water damage because windows are old style

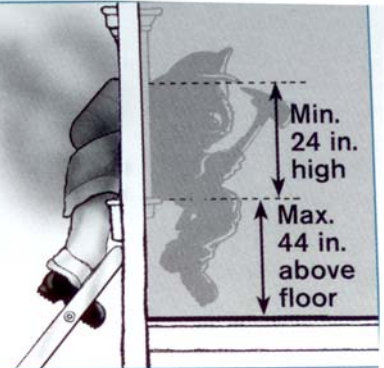
- 2) The window in the upstairs bedroom on the west side is too high from the floor and is too small for someone to get out of. See diagram. Every sleeping room shall have at least one operable emergency escape and rescue opening, which should not be more that 44" above the floor and not less than 5.7 square inches. The requirement for emergency escape and rescue openings in sleeping rooms exists because a fire will usually have spread before the occupants are aware of the problem, and the normal exit channels may be blocked. To be accessible from the interior of the sleeping room, the emergency escape and rescue opening cannot be located more than 44" above the floor. The 5.7 square inch opening is based on the minimum size necessary to admit a fire fighter with full rescue equipment.

This window is too high and too small by modern standards.

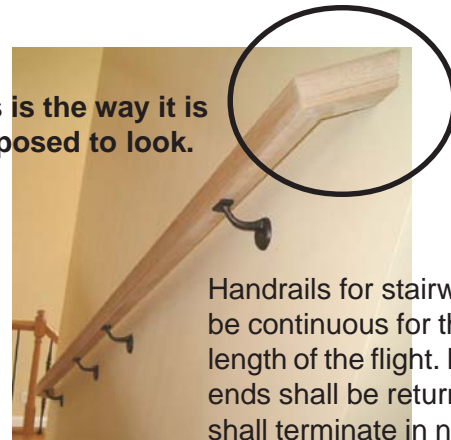
1) The handrail termination is incorrect. The handrail should end at a newel post or a wall to prevent catching clothing or limbs causing a fall. This means that the handrail should curve into the wall and not end abruptly like it does now.

Handrails for stairways shall be continuous for the full length of the flight. Handrail ends shall be returned or shall terminate in newel posts. (R311.5.6.2)

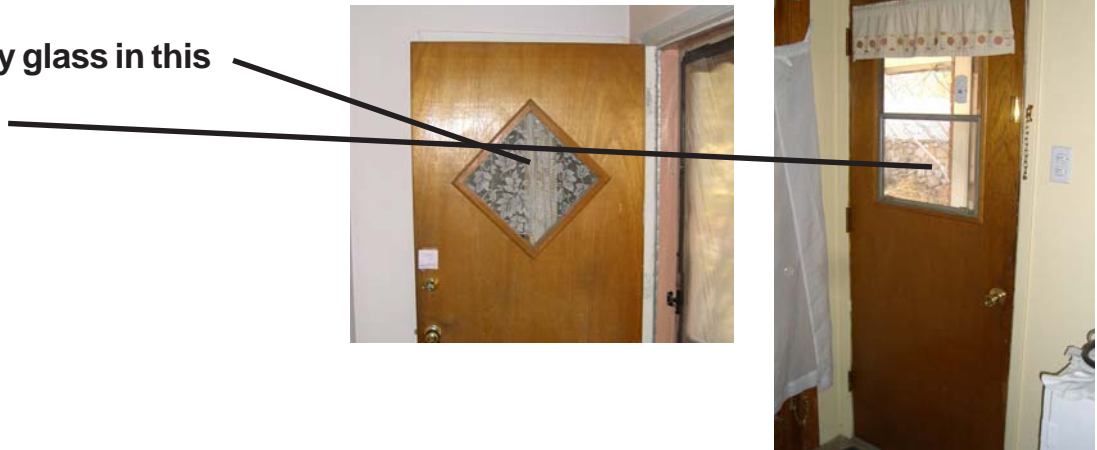
1) The glass in the exterior doors should be safety glass for safety reasons. I did not see any identification marks indicating that it is safety glass.

Should be safety glass in this location

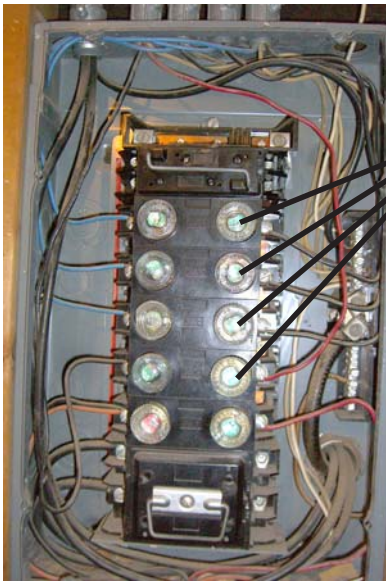
- 4) The top 4 fuses on the right had side should be 20 amp fuses and not 30 amp fuses. Over fusing can cause the wires to overheat, melt and even catch fire if an electrical problem should arise for these fuses.

These 4 fuses should be 20 amp

Below, hole should have grommet

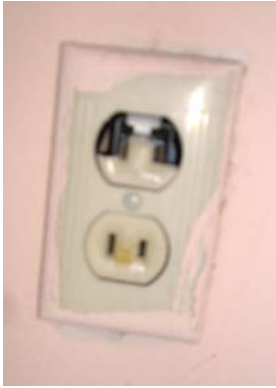
- 6) There is a damaged outlet in the living room that needs repair. This outlet has exposed "hot" parts that are dangerous.
- 7) Two outlets in the kitchen have reversed polarity. "Reverse polarity" is the term used to describe a situation where electrical wires are connected to the wrong terminals of a receptacle. It can be hazardous if the "hot" side of your electrical system gets connected to certain types of lamps or equipment.

Damaged outlet should be repaired because it is dangerous.

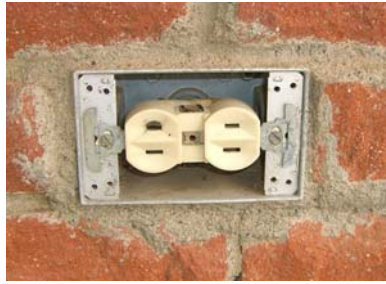
This outside outlet should be replaced with the new bubble type shown at right

This electrical "bubble covered" receptacle is acceptable for either wet or damp locations. I recommend a cover of this type to replace any outside outlet that needs to be replaced.

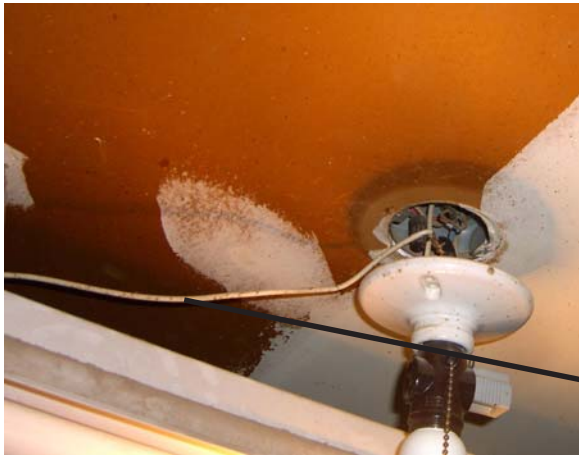
- 9) Two light fixtures are hanging out of the ceiling in the garage exposing the wires. This is deficient and can cause shock.

Exposed wires above the light fixtures in the garage should be covered to prevent damage and shock.

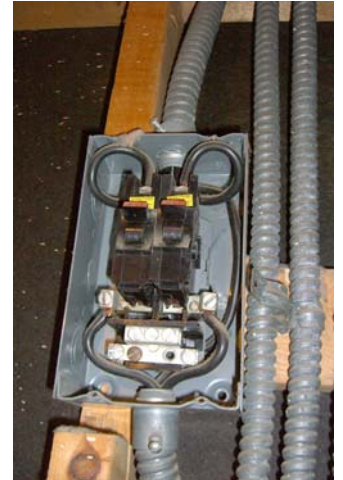
Cover should be placed over this box to prevent damage and shock hazard. →

Also, this wire should be in a conduit to protect it and to prevent any shocks.

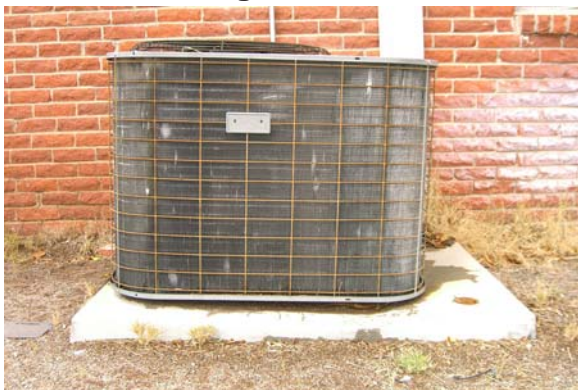
- 1) The foundation pad for the A/C is broke which is causing the A/C unit to lean. This leaning could effect the operation of the unit.
- 2) There is no filter/dryer installed in the system. See diagram.
- 3) There is no back-up safety on the secondary drain to prevent any water damage in the case if the primary drain should get plugged up.

Unit not sitting level

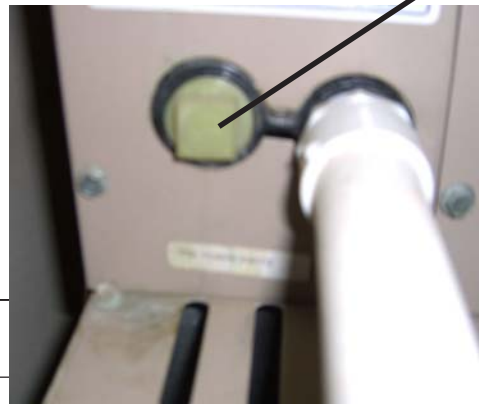
A back-up system to prevent any leaks should have been installed on the secondary drain here

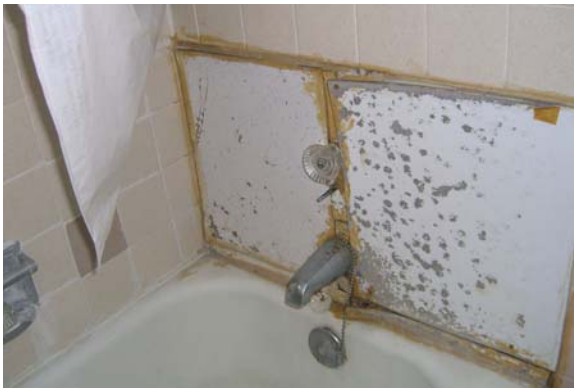
- 3) One of the outside faucets appears to need replacing. See photo.
- 4) The kitchen faucet leaks.
- 5) The downstairs bathtub plumbing leaks badly. It appears that the whole area needs repair to prevent water from getting behind the wall. I did not test the shower because of the bad leak.

This area in the downstairs bath is un-usable in its current condition.

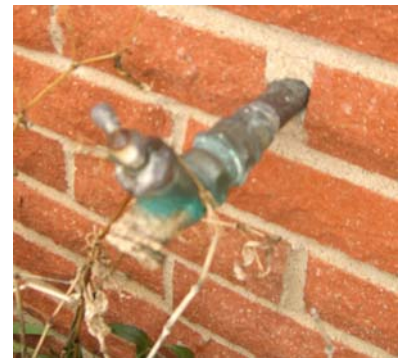
Faucet needs replacing.

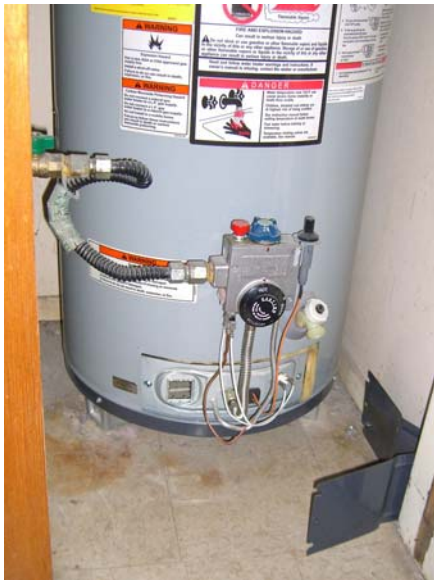
1) There is no safety pan present for the water heater. According to current standards where water heaters or hot water storage tanks are installed in locations where leakage of the tanks or connections will cause damage, the tank or water heater shall be installed in a safety pan. The safety pan should have a drain line (overflow pipe) that discharges into a proper location.

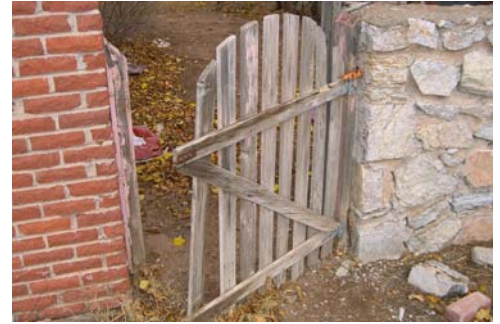
- 1) The pole holding up the front porch is completely rotted through at the bottom. The pole can be easily moved.
- 2) Both gates are beyond repair and should be replaced. See photo.
- 3) There is a lot of dead vegetation and trees and bushes that should be removed. All stumps and wood debris should be removed from around the house, otherwise, it can provide a source of food for a new termite colony that when it becomes large enough, will attack the house.
- 4) Most light fixtures around the house do not have globes to protect the bulbs.
