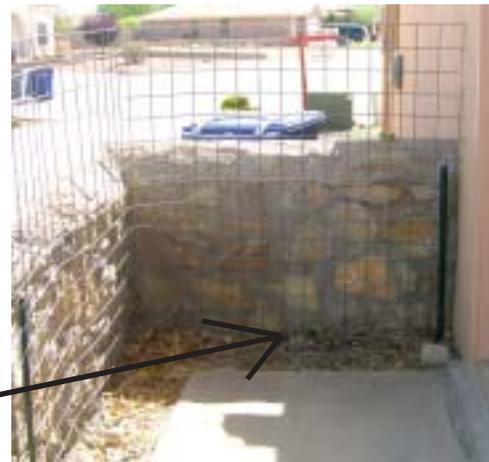
1) The drainage on the North side of the house is deficient. A large part of the roof drains into this area, there is no gate for the water to escape, and there is a hump in the yard preventing it from draining to the back. I believe that water will pond here after a rain. The solution to this issue would be to put a 4" drain pipe near the bottom of the wall to allow the water to escape to the front. I did not see any water damage to the house in this area. You may want to wait and see what this area looks like after a hard rain before you put a drain pipe in.

It would be a good idea to put a 4" drain pipe here to allow water to drain to the front.

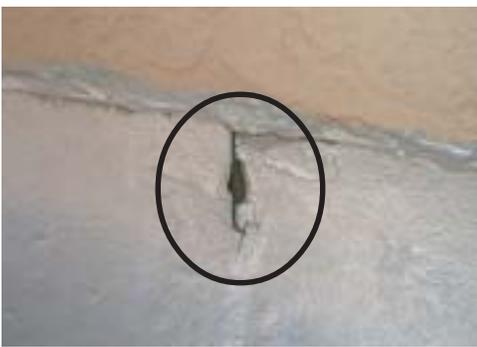
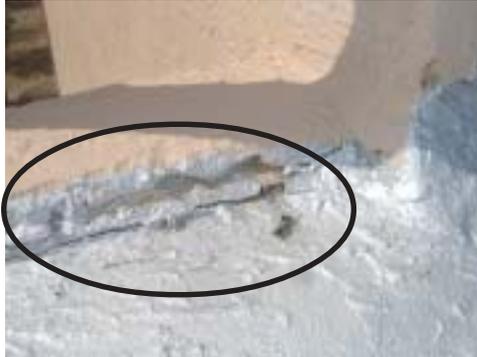
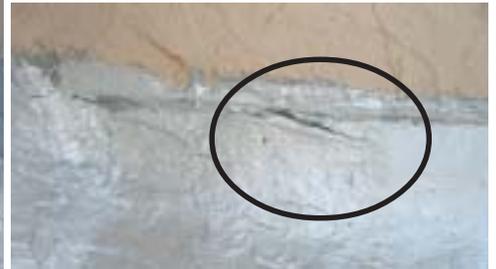
1) There were three small areas that need caulking/sealing. One in the front and two in the back. This caulking/sealing will prevent water from getting into the house.

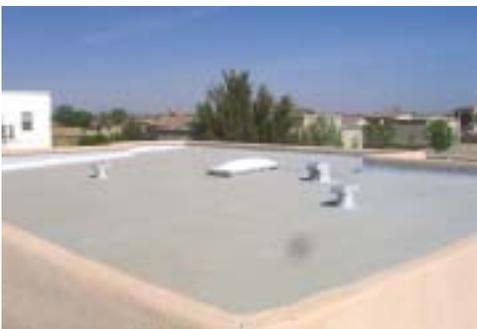
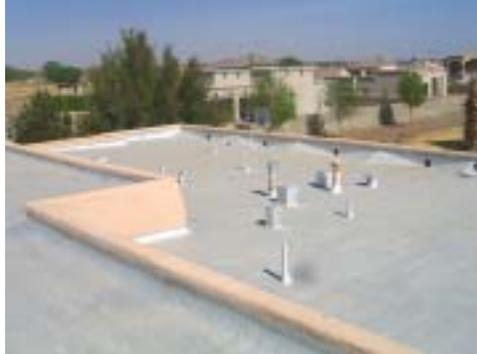
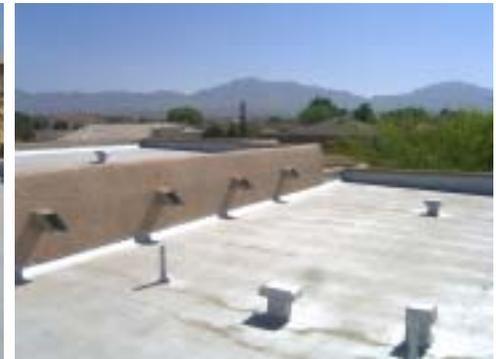
Roof shots

1) In the next several years you may want or need to apply a coat of Fibered Aluminum Roof Coating. This would be normal maintenance for a flat roof. This coating will fill any small cracks that have formed and will reflect the sun's rays much better, which will cool the house down.

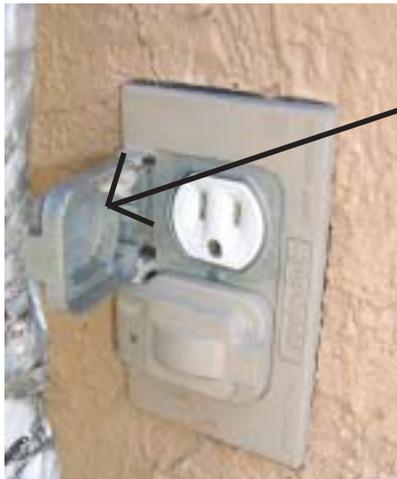
1)An outlet in the back near the water faucet has lost its weather seal. Since this outlet is exposed to the weather, I recommend that you replace this cover with a weather proof cover.

Your outlet has lost weather seal.

Recommend that you replace with a weather proof outlet cover, like sample on right.

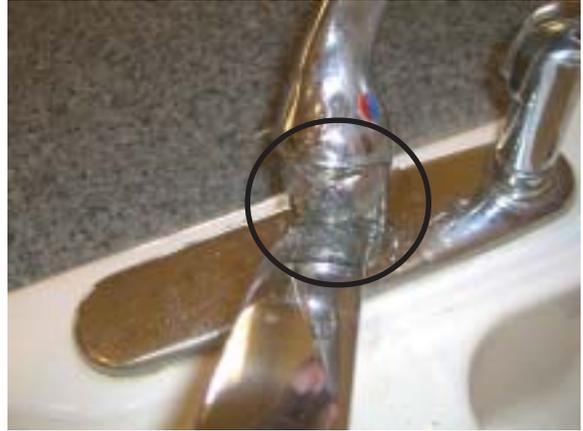
1) The kitchen faucet leaks when used.

Leak is at base of faucet in this area. It only leaks when used.

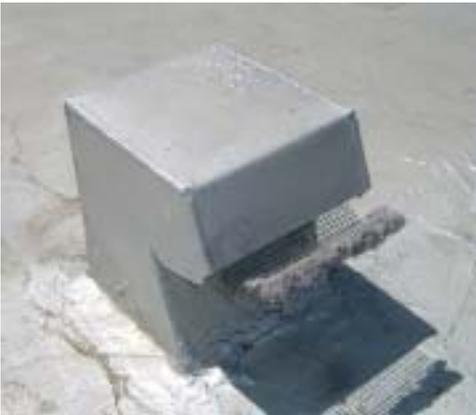
1) The dryer vent going out the roof is not the correct termination. Backdraft dampers must be installed in dryer exhaust ducts to avoid outdoor air infiltration during periods when the dryer is not operating and to prevent the entry of animals. These dampers should be designed and installed to provide an adequate seal when in a closed position to minimize air leakage. Screens and/or sheet metal screws are prohibited on the duct termination because lint from the dryer will eventually clog the screen or catch on the screws to the point that no exhaust air will be able to reach the outdoors. This will build up to the point that a fire hazard is created.

Your vent is on the left. As you can see, the screen was starting to get plugged up with lint.

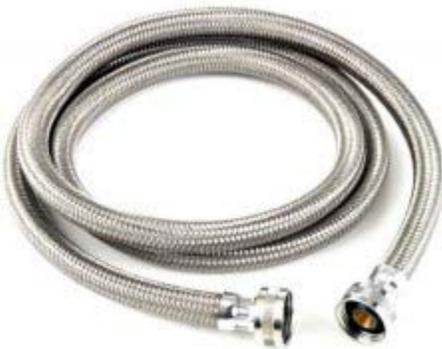
Steel braided hoses

* The standard black hoses typical on a washer hookup are not approved for use as permanent water lines; over time, hoses left pressurized will blister and ultimately explode. Washer hoses that are left pressurized all the time should be stainless-steel braided. The number one claim with all insurance companies is washing machine hoses bursting. The water is constantly under pressure. The normal black rubber hoses become weakened within a few years of installation. Replace those old rubber hoses with these braided steel “no burst” hoses.

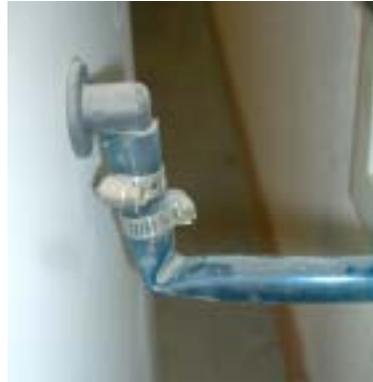
- 1) The ceiling fan in the master bedroom does not work.
- 2) A blue hose to the water softener has a kink in it. I do not inspect water softeners, but I just noticed this item.

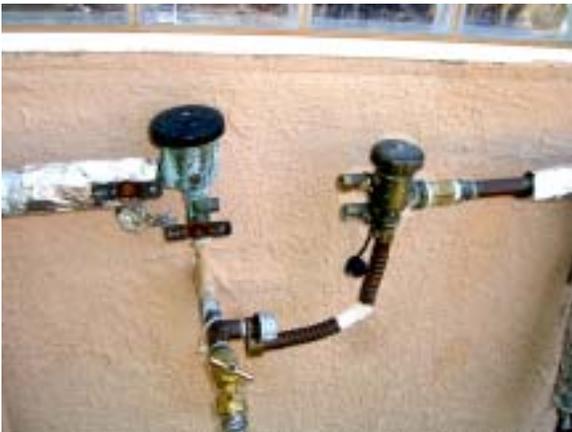
- 3) I do not inspect the sprinkler system either, but I want to point out that the current atmospheric vacuum breaker in use is not allowed anymore. If you upgrade your sprinkler system, you will probably be required to upgrade the vacuum breaker to the new one allowed. They cost about \$450. Also, I believe your sprinkler system has multiple leaks in it in this area. See photo.

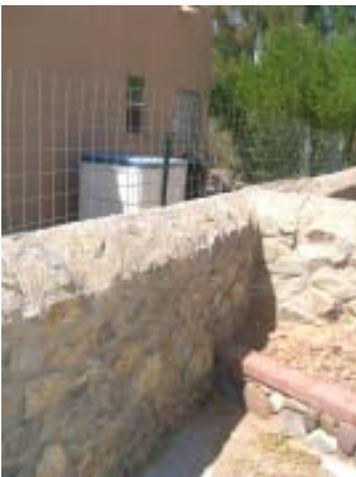
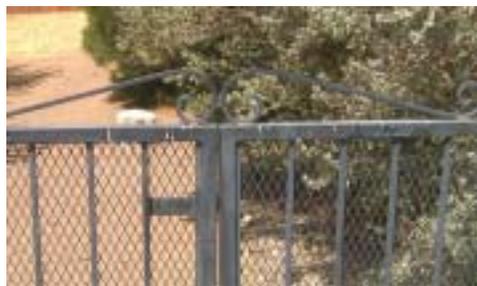
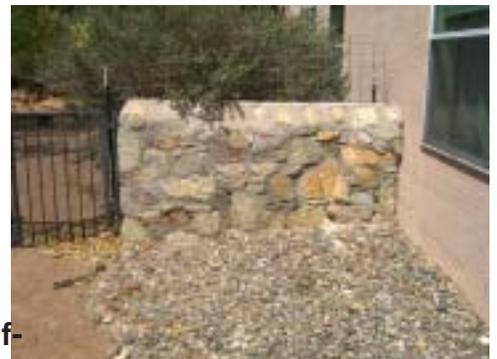
Left photo shows climbable wall.
Center photo is a gate that is not self-closing. Right photo shows the wall not being 48" high on the right hand side.

- ♦ Where a wall of a dwelling serves as part of the barrier, one of the three following conditions shall be met:
 - 1) The pool shall be equipped with a power cover or

- 2) Doors with direct access to the pool through that wall shall be equipped with an audible which produces a warning when the door and/or its screen are opened, or

- 3) Doors to the pool have self-latching and self-closing devices.

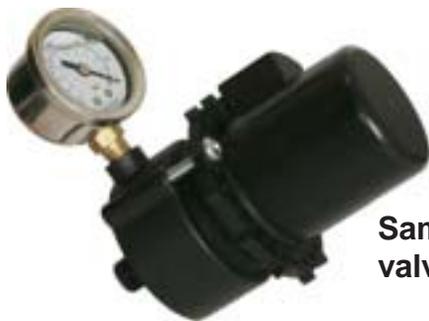
3) There is no anti-entrapment device present for the pool. All swimming pools and spas shall be equipped with proper anti-entrapment drain covers and circulation and drainage systems. Vacuum devices for suction inlet systems in pool water circulations are a safety hazard. Body entrapment or hair entrapment can cause serious injury. Therefore, it is important that protection be provided against possible entrapment at the pool entrances to suction inlets and that vacuum relief be provided for the vacuum system.

Sample of an anti-entrapment valve.

Sample of an anti-entrapment drain cover.

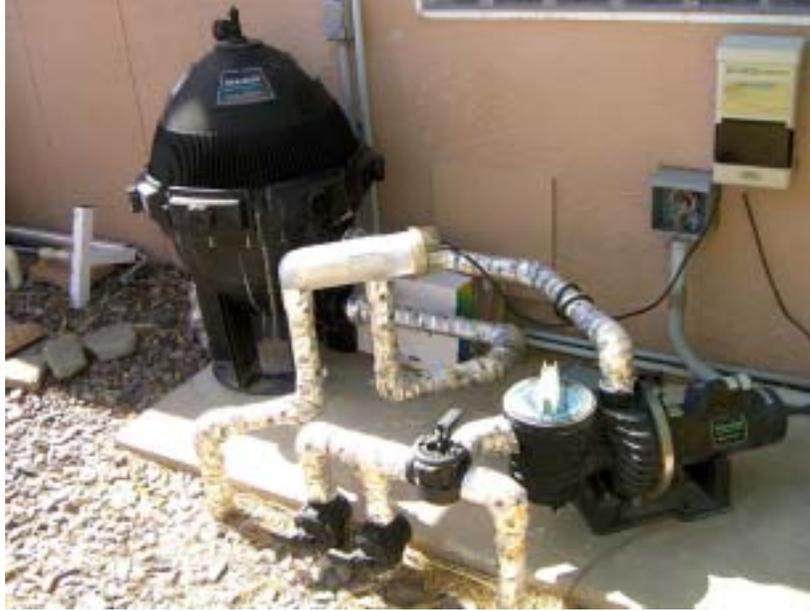
Pool equipment

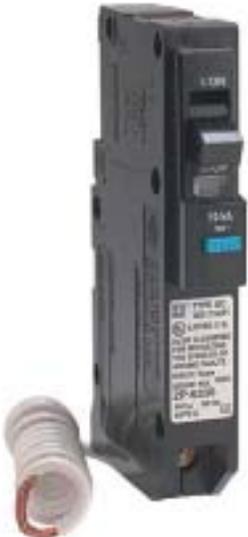
AFCI Breaker

An arc fault circuit interrupter (AFCI) is a newly developed circuit breaker designed to prevent fires by detecting non-working electrical arcs and disconnecting power before the arc starts a fire. Arc faults in a home is one of the leading causes for household fires. AFCI breaker devices are primarily designed to protect against fire. AFCI installation of the combination type is required in bedrooms, family rooms, dining rooms, living rooms, parlors, libraries, dens, sunrooms, recreation rooms, closets, hallways, and similar rooms or areas of new residential construction. (NEC 210.12B)

When an electrical switch is opened or closed, an arc, or discharge of electricity across a circuit, occurs. Unintentional arcs can occur at loose connections or where wires or cords have been damaged. Such arcs can lead to high temperatures and sparking, possibly igniting combustibles. AFCIs (arc-fault circuit-interrupters) protect against fire by continuously monitoring the electrical current in a circuit and shutting off the circuit

when unintended arcing occurs. These devices are designed to discriminate between unintended arcing and the type of arcing that occurs when a switch is operated. AFCIs are an important safety addition to homes in part because they address an additional type of electrical fault that can cause a fire and one which may not be detected and interrupted by a conventional circuit breaker, nor by a ground-fault circuit interrupter (GFCI's).

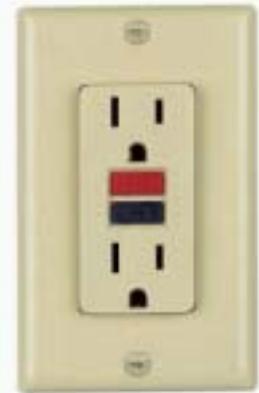
GFCI Outlet

GFCI outlets are designed to protect against electrical shock. A GFCI is a safety device that senses any shock hazard and interrupts the flow of electricity in the circuit before a person can be electrocuted. The GFCI is designed to trip and interrupt the circuit at approximately 5 to 8 milliamps.

GFCI's are found in the kitchen, the bathroom, outdoors, garages, crawl spaces, unfinished basements and near swimming pools.
