Advantage Home Inspections

PROPERTY INSPECTION REPORT

State of Occupancy: unoccupied **Age: New**

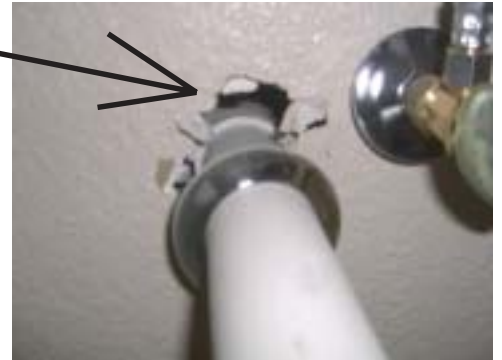
■ □ □ ■ Interior Walls

COMMENTS ON DEFICIENCIES: The wall under the middle bedroom bathroom sink should be sealed to prevent any rodents and/or insects from getting into the house.

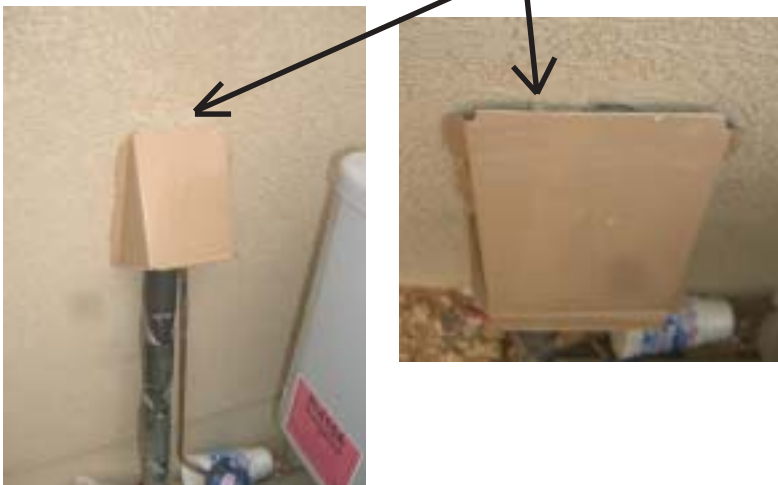
■ □ □ ■ E. Exterior Walls

COMMENTS ON DEFICIENCIES: The siding protection for the A/C pipes should be sealed to prevent any water penetration.

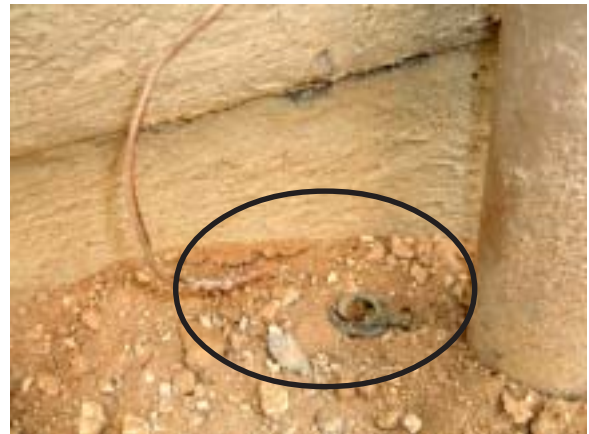
3) The ground wire was damaged at the ground rod and has come apart. This is a very important connection and must be installed correctly.

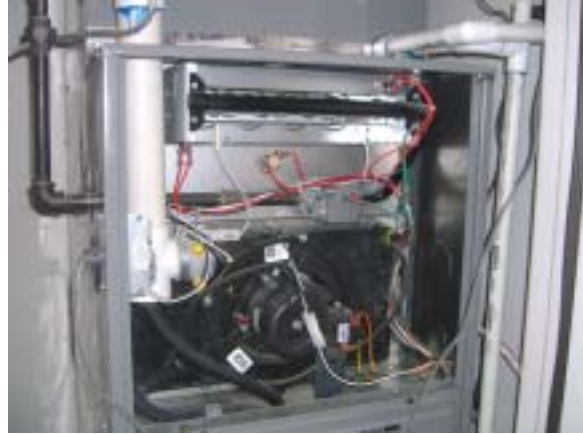
There was no gas meter so I could not operate the unit. I inspected it for installation and safety and found it to be satisfactory.

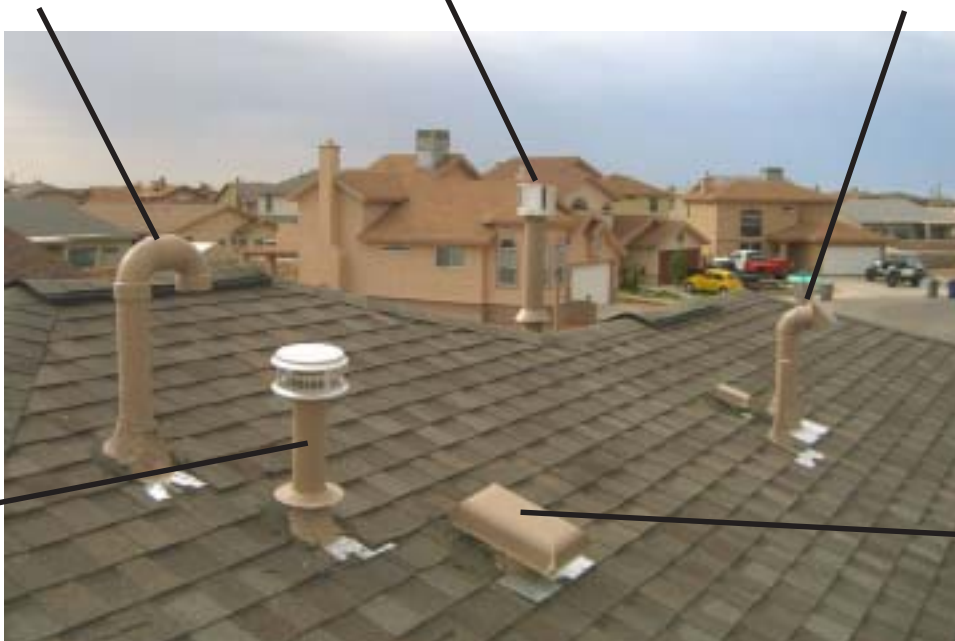
High efficiency furnace flue

Gas fireplace flue

Back draft damper for the dryer vent

Water heater flue

Combustion air vent for water heater and furnace

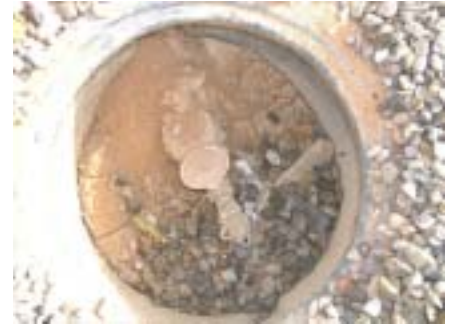
1) The water meter vault is full of debris and should be cleaned out.
 Comments: Water pressure should be between 40 and 80 psi.
 Yours is on the low side but is within tolerance.

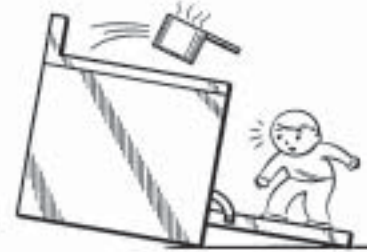
1) Although there is a anti-tip bracket installed on the floor, it does not engage the oven. This allows the oven to tip forward when a weight is put on the door. This is a safety issue to prevent children from gettin burned by hot liquid if they should stand on the oven door.

To protect your children, keep the anti-tip device installed correctly.

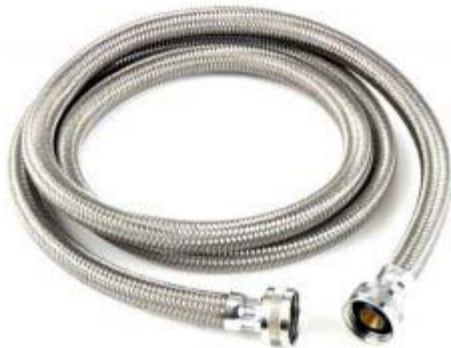
Steel braided hoses

* The standard black hoses typical on a washer hookup are not approved for use as permanent water lines; over time, hoses left pressurized will blister and ultimately explode. Washer hoses that are left pressurized all the time should be stainless-steel braided. The number one claim with all insurance companies is washing machine hoses bursting. The water is constantly under pressure. The normal black rubber hoses become weakened within a few years of installation. Replace those old rubber hoses with these braided steel "no burst" hoses.

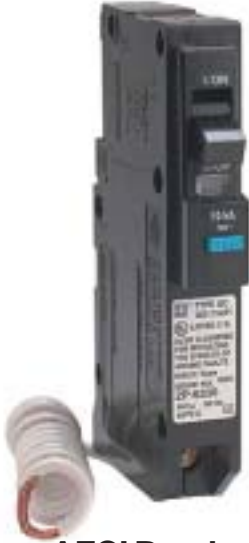
AFCI Breaker

An arc fault circuit interrupter (AFCI) is a newly developed circuit breaker designed to prevent fires by detecting non-working electrical arcs and disconnecting power before the arc starts a fire. Arc faults in a home is one of the leading causes for household fires. AFCI breaker devices are primarily designed to protect against fire. AFCI installation of the combination type is required in bedrooms, family rooms, dining rooms, living rooms, parlors, libraries, dens, sunrooms, recreation rooms, closets, hallways, and similar rooms or areas of new residential construction. (NEC 210.12B) When an electrical switch is opened or closed, an arc, or discharge of electricity across a circuit, occurs. Unintentional arcs can occur at loose connections or where wires or cords have been damaged. Such arcs can lead to high temperatures and sparking, possibly igniting combustibles. AFCIs (arc-fault circuit-interrupters) protect against fire by continuously monitoring the electrical current in a circuit and shutting off the circuit when unintended arcing occurs. These devices are designed to discriminate between

unintended arcing and the type of arcing that occurs when a switch is operated. AFCIs are an important safety addition to homes in part because they address an additional type of electrical fault that can cause a fire and one which may not be detected and interrupted by a conventional circuit breaker, nor by a ground-fault circuit interrupter (GFCI's).

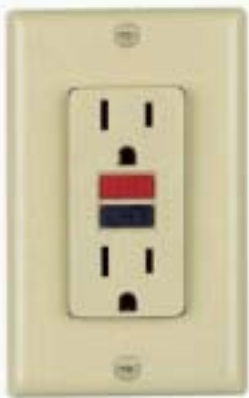
GFCI Outlet

GFCI outlets are designed to protect against electrical shock. A GFCI is a safety device that senses any shock hazard and interrupts the flow of electricity in the circuit before a person can be electrocuted. The GFCI is designed to trip and interrupt the circuit at approximately 5 to 8 milliamps.

GFCI's are found in the kitchen, the bathroom, outdoors, garages, crawl spaces, unfinished basements and near swimming pools.
