Advantage Home Inspections

PROPERTY INSPECTION REPORT

Weather Clear	Temperature 85	Faces N	Time 10:00 am
State of Occupancy: unoccupied		Age New - 2010	
Sq footage Approx. 1250		Present at inspection:

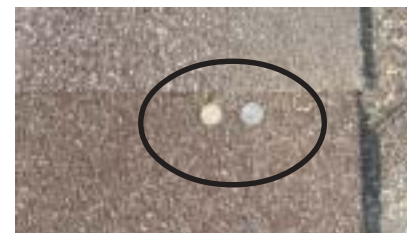
1) There are several exposed nail heads in various locations on the roof. These nail heads should be sealed to prevent any water penetration.

Example of exposed nail heads

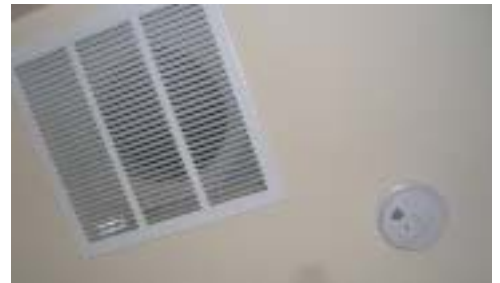
- 1) There is no smoke alarm in the hall as is required in this location.
- 2) The smoke alarm in the front corner bedroom does not sound loudly enough.
- 3) The smoke alarm outside the front bedroom is too close to a vent. Vents should be at least 3 feet away from smoke alarms. A vent too close to the alarm can affect the operation of the alarm.

Vent too close to alarm

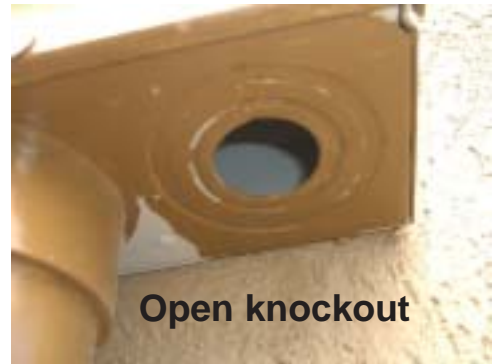
3) There is an open knockout in the bottom of the meter. Boxes and enclosures must have the integrity to keep out foreign objects, protect the conductors and devices therein, contain any arcing or hot materials resulting from faults and splice failures in the box or enclosure and protect persons from accidental contact with energized components.

Open knockout

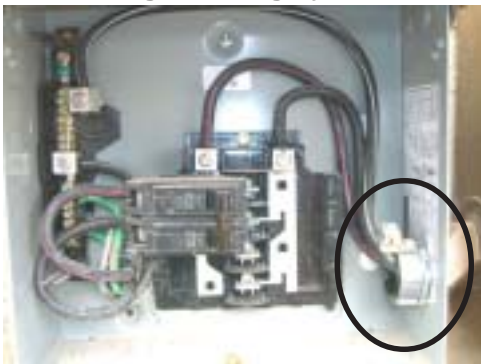
4) The bonding lock inside the panel does not have a ground wire attached to it. This is necessary to insure proper bonding for the electrical grounding system.

No bonding wire is present at this location

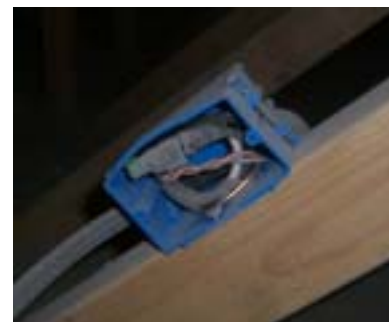
1) An outlet in the attic does not have a protective cover to protect against shock.

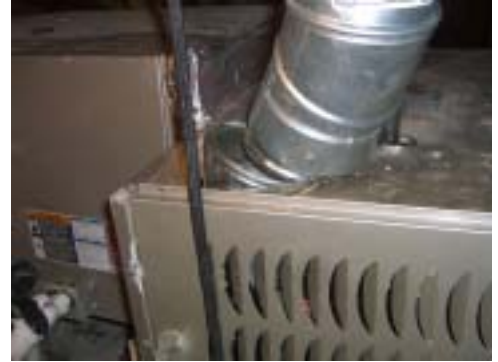
- 1) The flue pipe is not attached to the furnace. This will allow carbon monoxide to escape into the attic which could possibly get into the house.

Flue pipe not properly connected.

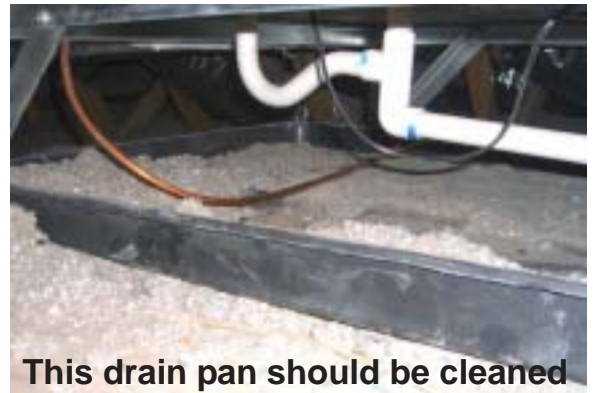
- 1) The drain pan underneath the unit to collect evaporative water overflow has rock wool insulation in it. This should be cleaned out for two reasons:
 - a) any leakage will be absorbed by the insulation not allowing it to flow out the pan drain.
 - b) this insulation could easily clog the pan drain which will allow it to back up and over flow damaging the ceiling.
 The pan should be cleaned out with no insulation in it.

This drain pan should be cleaned out to prevent problems with the drain for the pan.

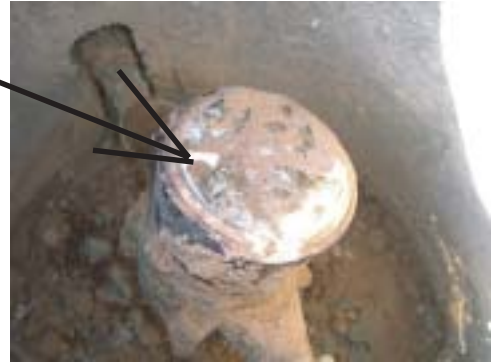
1) The glass is broken on the water meter. It appears that the gauge is damaged also.

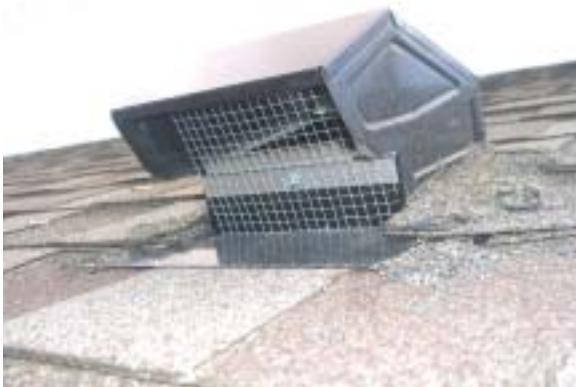
1) The dryer vent out the roof was incorrect. Backdraft dampers must be installed in dryer exhaust ducts to avoid outdoor air infiltration during periods when the dryer is not operating and to prevent the entry of animals. These dampers should be designed and installed to provide an adequate seal when in a closed position to minimize air leakage. Screens and/or sheet metal screws are prohibited on the duct termination because lint from the dryer will eventually clog the screen or catch on the screws to the point that no exhaust air will be able to reach the outdoors. This will build up to the point that a fire hazard is created.

The vent on the left is your incorrect vent. The vent on the right is what a sample correct vent should look like.

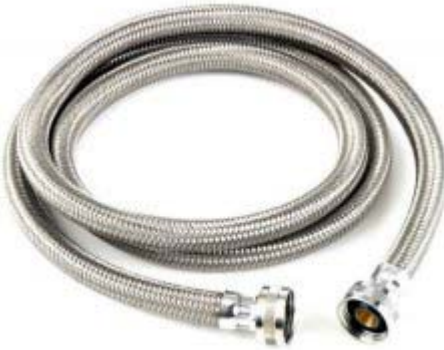
Steel braided hoses

* The standard black hoses typical on a washer hookup are not approved for use as permanent water lines; over time, hoses left pressurized will blister and ultimately explode. Washer hoses that are left pressurized all the time should be stainless-steel braided. The number one claim with all insurance companies is washing machine hoses bursting. The water is constantly under pressure. The normal black rubber hoses become weakened within a few years of installation. Replace those old rubber hoses with these braided steel “no burst” hoses.

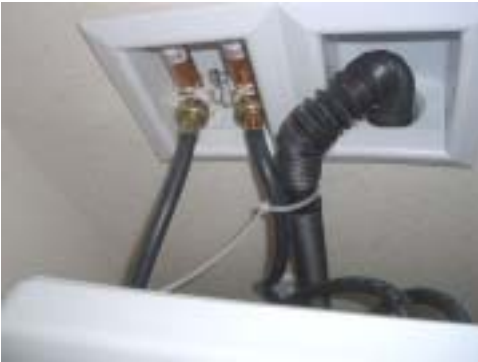
These are your rubber hoses that should be replaced.

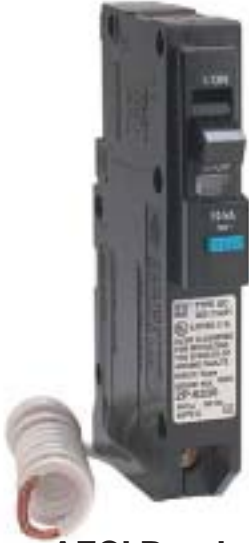
AFCI Breaker

An arc fault circuit interrupter (AFCI) is a newly developed circuit breaker designed to prevent fires by detecting non-working electrical arcs and disconnecting power before the arc starts a fire. Arc faults in a home is one of the leading causes for household fires. AFCI breaker devices are primarily designed to protect against fire. AFCI installation of the combination type is required in bedrooms, family rooms, dining rooms, living rooms, parlors, libraries, dens, sunrooms, recreation rooms, closets, hallways, and similar rooms or areas of new residential construction. (NEC 210.12B) When an electrical switch is opened or closed, an arc, or discharge of electricity across a circuit, occurs. Unintentional arcs can occur at loose connections or where wires or cords have been damaged. Such arcs can lead to high temperatures and sparking, possibly igniting combustibles. AFCIs (arc-fault circuit-interrupters) protect against fire by continuously monitoring the electrical current in a circuit and shutting off the circuit when unintended arcing occurs. These devices are designed to discriminate between unintended arcing
