Advantage Home Inspections

PROPERTY INSPECTION REPORT

Concerning: _____ **01-26-12**
(Address or Other Identification of Inspected Property) (Date)

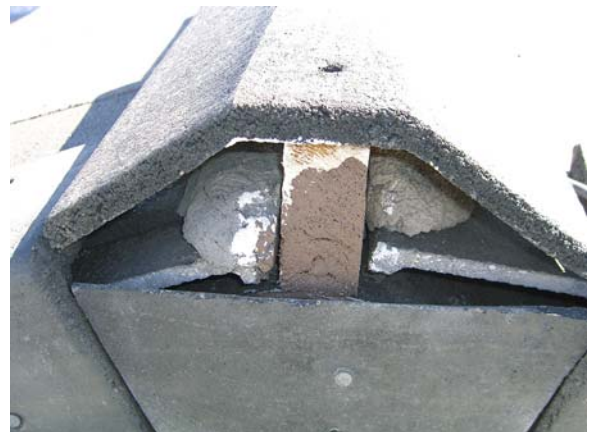
1) One end of the ridge on the roof needs protection from rain penetration. See photo.

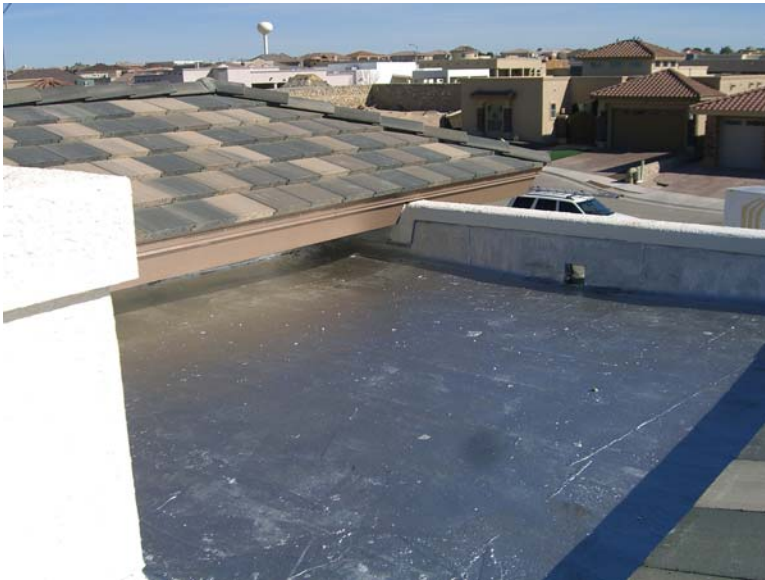
Photo of roof portion.
I don't see a low spot in the photo.

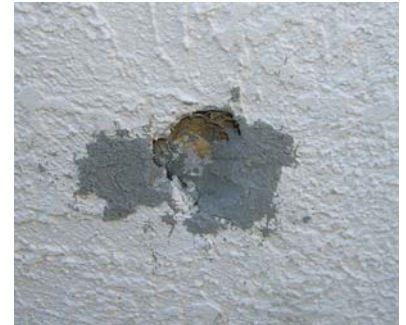
1) Hole in the wall on the North side. It is an access to a drain and needs a cover plate.

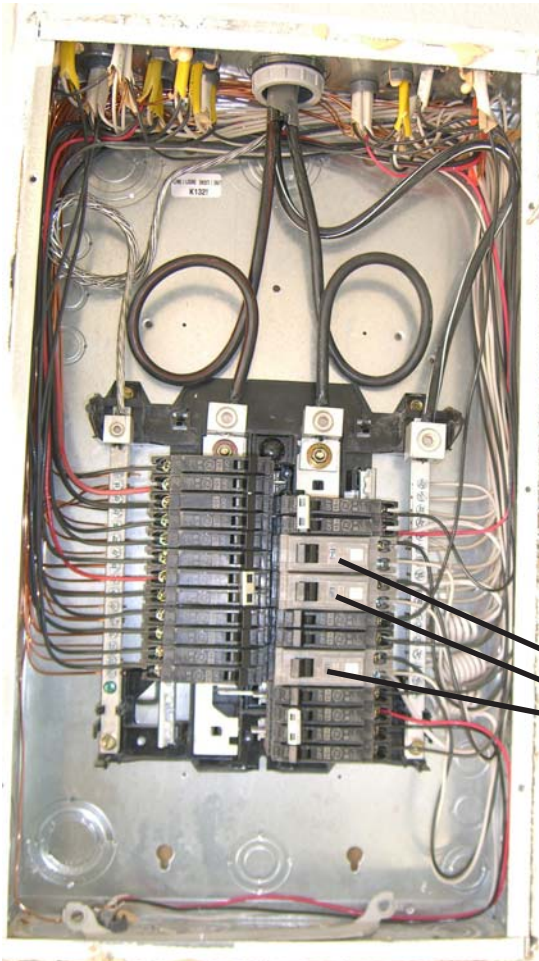
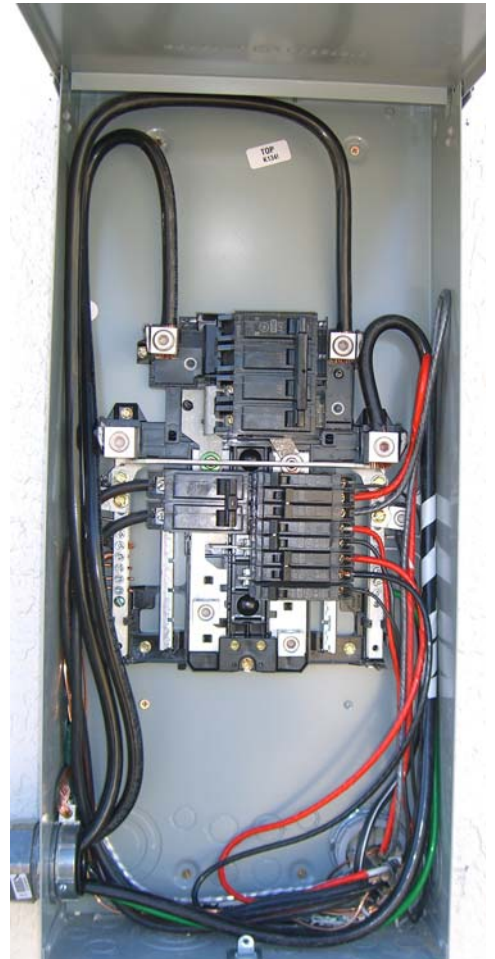
- 1) AFCI's are not in all the required locations. Beginning in 2011 all outlets for new homes in bedrooms, family rooms, dining rooms, living rooms, parlors, libraries, dens, sunrooms, recreation rooms, closets, hallways, and similar rooms are required to be AFCI protected. (E3902.11). AFCI's are not in the family room, the dining room, the living room, parlor, library, den, closets or hallway. [Please look at Appendix A at the end of this report for more information concerning AFCI's.](#)
- 2) The meter did not have a city seal.

Main panel (r)

sub-panel (l)

Only 3 AFCI's in the panel. These are for the bedrooms only. Need more AFCI's for other required locations

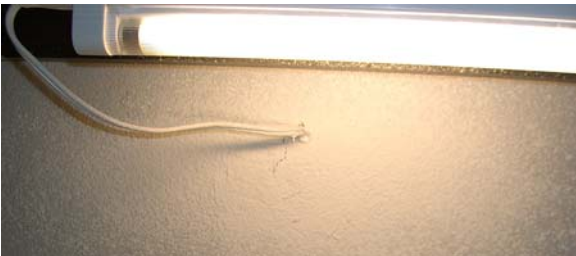
- 6) There is an unprotected electrical cord going through the wall under each of the master bathroom sinks. This is not allowed.
- 7) The two outlets on the roof for the A/C units are damp proof and they should be wet proof.

Electric cord going through the wall.

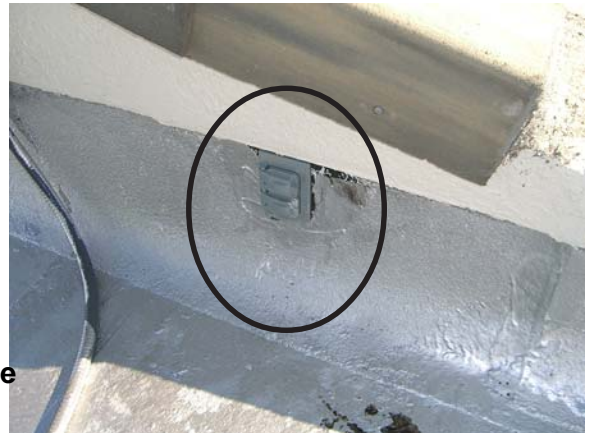
These outlets on the roof should be weather proof.

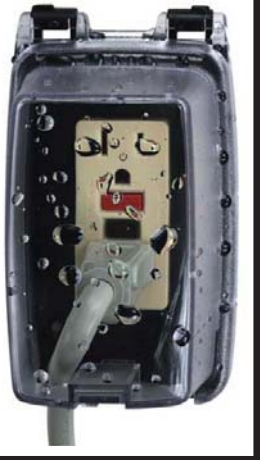
This electrical "bubble covered" receptacle is acceptable for either wet or damp locations. I recommend a cover of this type to replace any outside outlet that needs to be replaced.

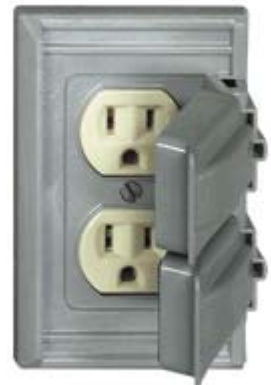
On the right is an example of a damp location outlet and on the left is an example of a wet location outlet.

A damp location outlet is one that is protected by an overhang like a patio roof or a wide soffit. Water does not directly strike them. A wet location outlet is out in the open where rain or sprinklers can hit them.

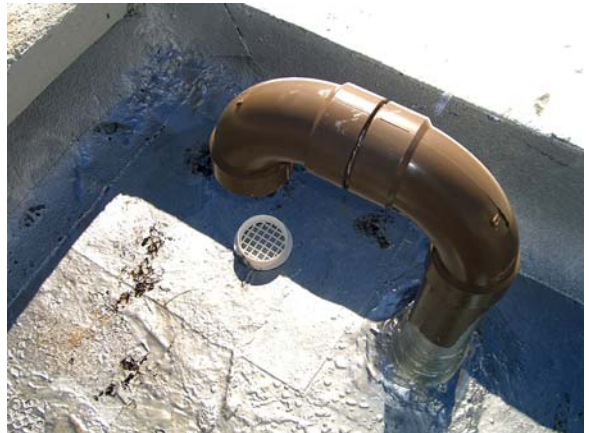
1) One cap was missing and the other kept falling out for the vent pipe and the flue pipe for the tankless water heater. These caps will prevent animals / birds from getting into them.

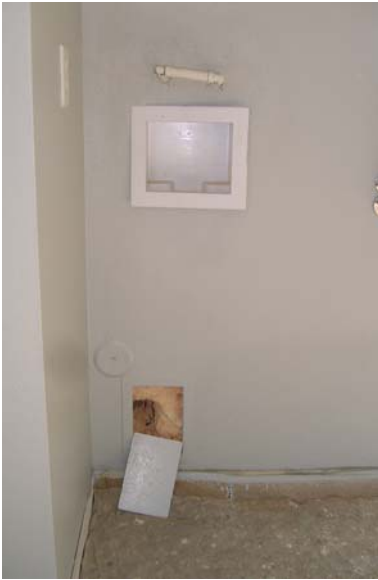
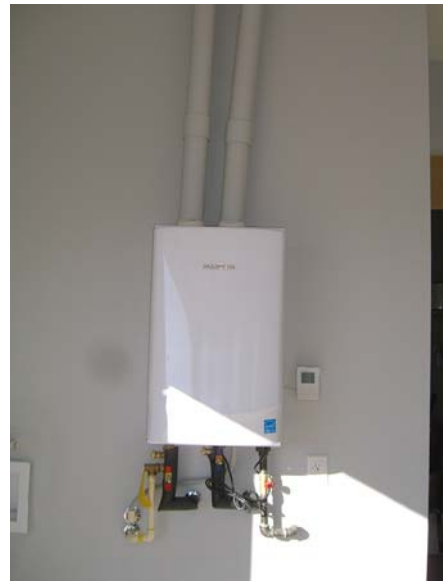
- 1) If a water softener is installed, I believe that it will block access to the water shut off valve.
- 2) Water pressure is low for the sink and the shower head on the right side of the master bath room.

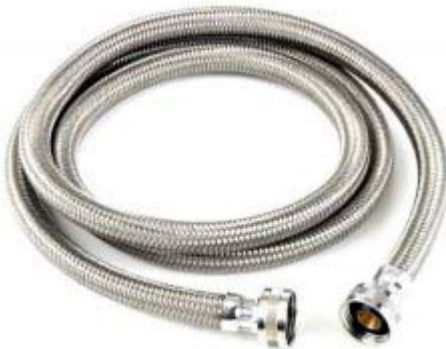
Steel braided hoses

* The standard black hoses typical on a washer hookup are not approved for use as permanent water lines; over time, hoses left pressurized will blister and ultimately explode. Washer hoses that are left pressurized all the time should be stainless-steel braided. The number one claim with all insurance companies is washing machine hoses bursting. The water is constantly under pressure. The normal black rubber hoses become weakened within a few years of installation. Replace those old rubber hoses with these braided steel “no burst” hoses.

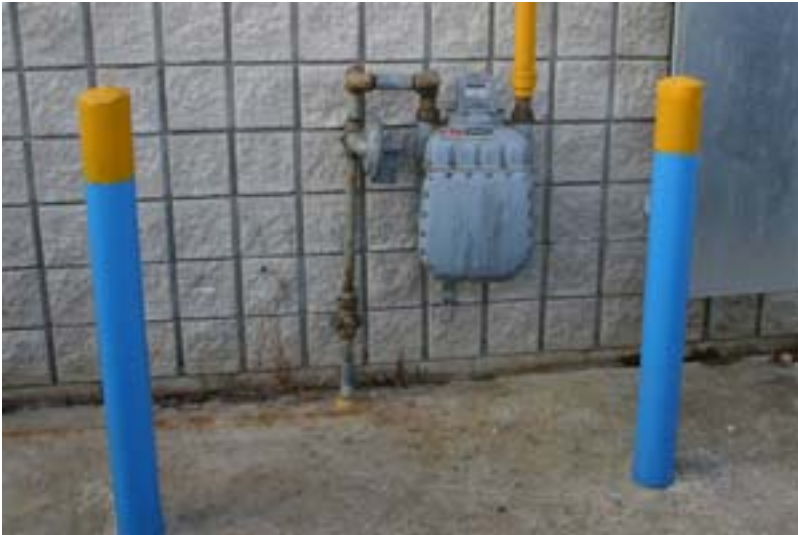
Example of barriers to protect gas meter.

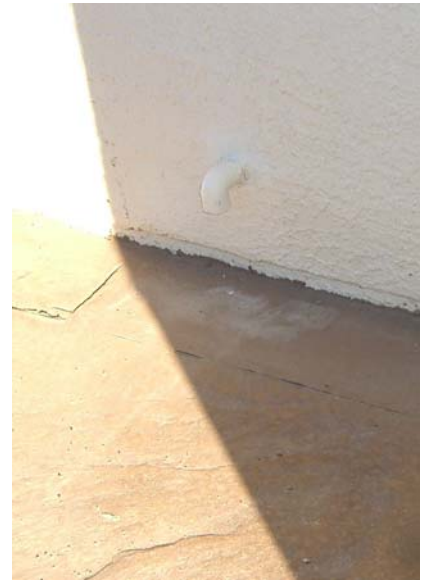
1) The late addition of the driveway on the South side of the house has caused two problems.
a) The A/C condensate line now drains onto the driveway. In a short time this area will be green with slime and constantly wet in the summer. The A/C line is not supposed to drain onto a driveway for this reason. Condensate shall not discharge into a street, alley or other areas where it will cause a nuisance. (M1411.13)
b) The gas meter is unprotected from impact by a vehicle. You can solve this problem by putting in an approved barrier. The approval of the barrier will be up to the gas company. I don't think the gas company will even install the meter without the barrier in place first.
See photo next page for an example of a pipe barrier.

A/C condensate line will make a mess in this area.

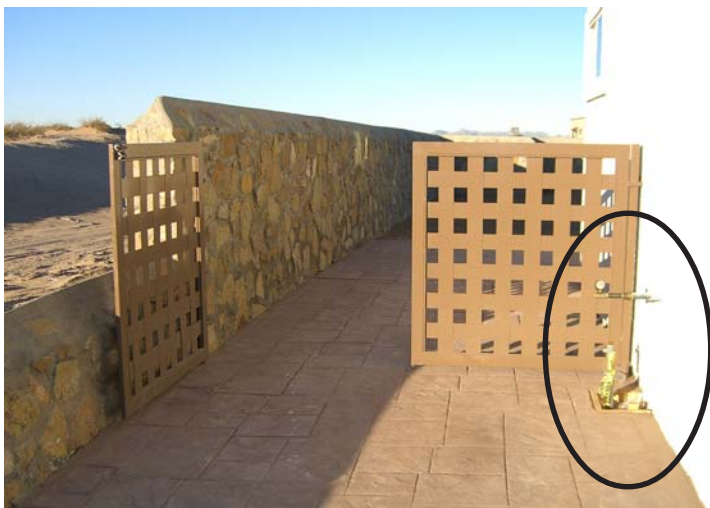
Your gas meter is in the driveway where it can be hit by a car.
