# Advantage Home Inspections

## PROPERTY INSPECTION REPORT

Concerning: \_\_\_\_\_ **01-21-12**  
(Address or Other Identification of Inspected Property) (Date)

By: **Don Powell 8534** \_\_\_\_\_  
(Name and License Number of Inspector) (Name of Realtor)

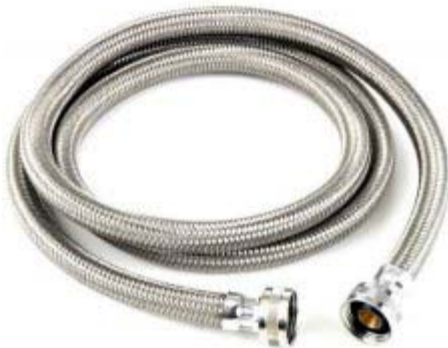
Steel braided hoses

\* The standard black hoses typical on a washer hookup are not approved for use as permanent water lines; over time, hoses left pressurized will blister and ultimately explode. Washer hoses that are left pressurized all the time should be stainless-steel braided. The number one claim with all insurance companies is washing machine hoses bursting. The water is constantly under pressure. The normal black rubber hoses become weakened within a few years of installation. Replace those old rubber hoses with these braided steel "no burst" hoses.

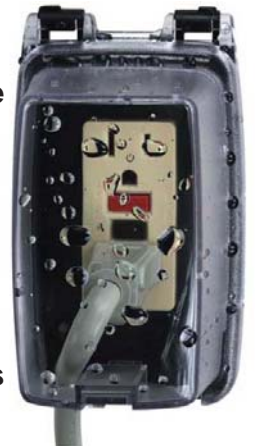
This electrical “bubble covered” receptacle is acceptable for either wet or damp locations. I recommend a cover of this type to replace any outside outlet that needs to be replaced.
