Advantage Home Inspections

PROPERTY INSPECTION REPORT

Concerning: _____ **11-25-11**
(Address or Other Identification of Inspected Property) (Date)

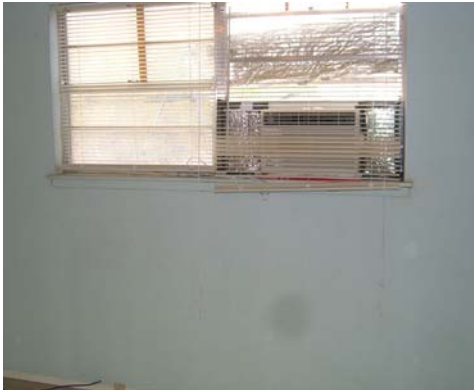
FIG. 56 Bedroom Window Egress

When the req'd second exit in a bedroom is a window, it must open to a size that provides an escape route for residents & an entrance for a firefighter wearing an oxygen pack. The sill must not be higher than 44 in. from the finished floor. The openable portion of the window must be at least 24 in. high & 20 in wide, w/ a net area at least 5.7 sq. ft., per **T26**. If the window is at direct grade level, the overall size may be reduced to 5.0 sq. ft. per **T27**.

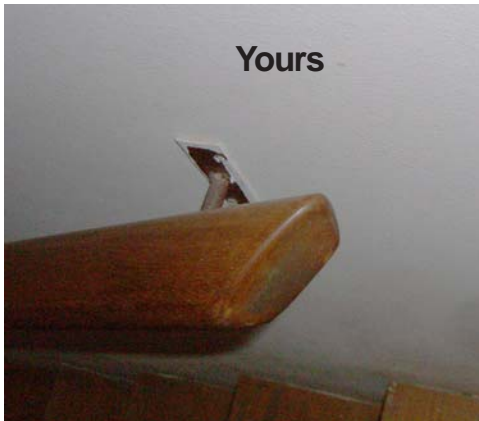
1) The handrail termination is incorrect. The handrail should end at a newel post or a wall to prevent catching clothing or limbs causing a fall. This means that the handrail should curve into the wall and not end abruptly like it does now.

This is the way it is supposed to look.

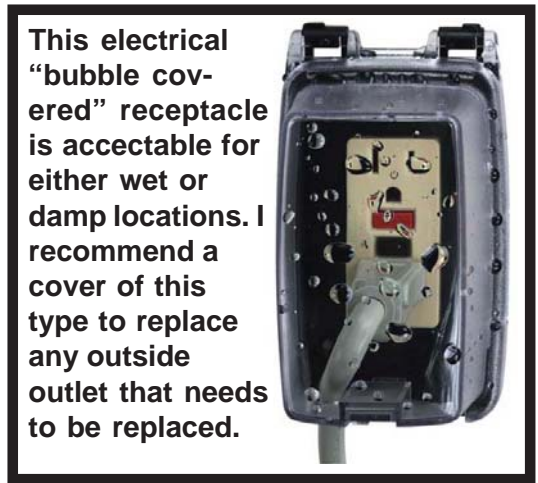
This outside outlet should be replaced with the new bubble type shown at right

This electrical "bubble covered" receptacle is acceptable for either wet or damp locations. I recommend a cover of this type to replace any outside outlet that needs to be replaced.

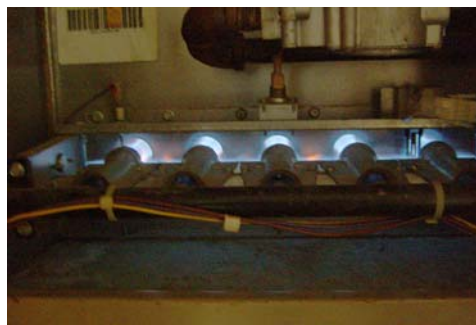
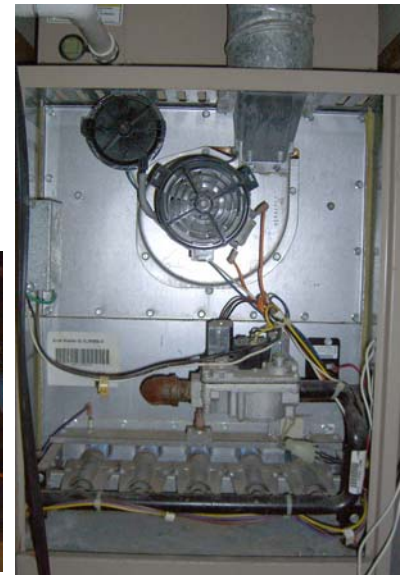
- 1) The furnace filter is dirty and should be replaced.
- 2) Neither bath room has a vent to it for heating and cooling. They both have ceiling heaters. The ceiling heater for the upstairs bathroom does not work.

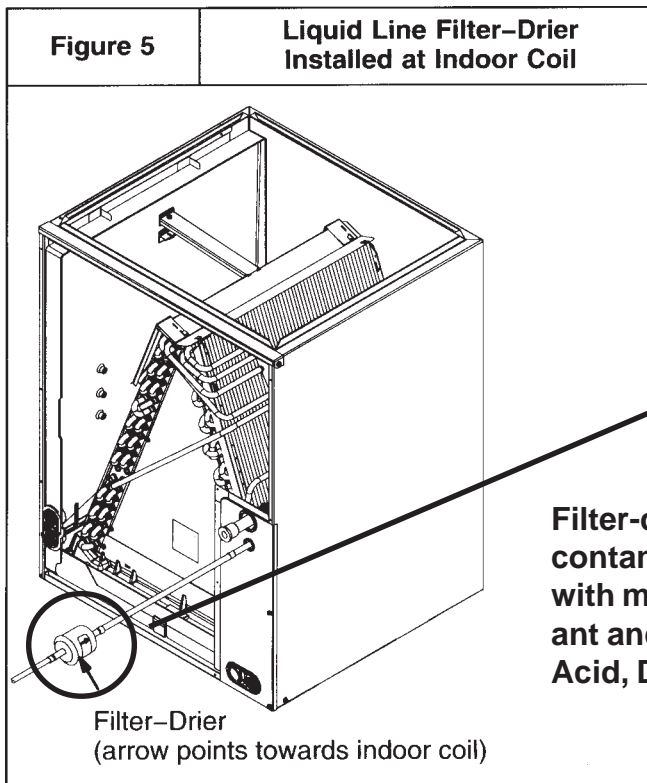
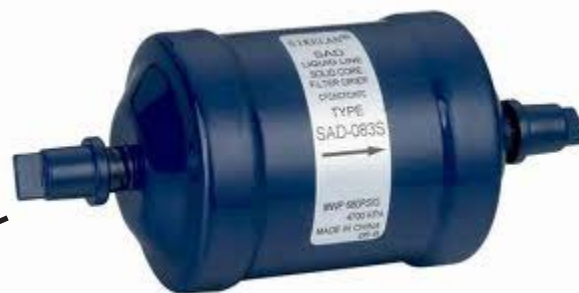
Filter-driers are used to remove unwanted contaminants from the refrigeration system with minimal resistance to the flow of refrigerant and oil. The contaminants are: Moisture, Acid, Debris, and Wax.

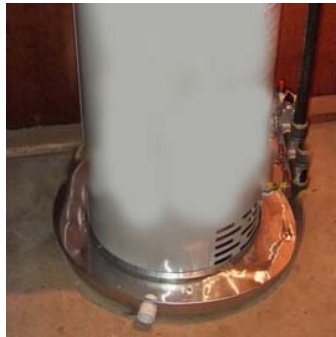
1) There is no safety pan present for the water heater. According to current standards where water heaters or hot water storage tanks are installed in locations where leakage of the tanks or connections will cause damage, the tank or water heater shall be installed in a safety pan. The safety pan should have a drain line (overflow pipe) that discharges into a proper location.

This is what a safety pan looks like

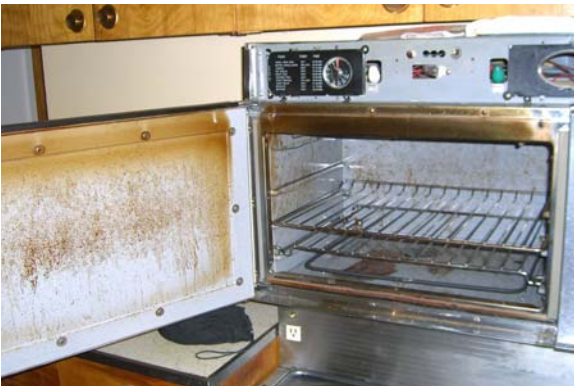
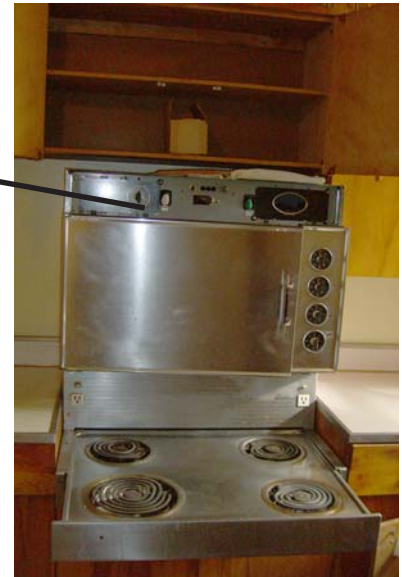
2) The panel was missing on the top for the controls.

3) The door is loose. You have to raise it to get the door to close.
